PROPERTY INSPECTION REPORT

SUMMIT
HOME INSPECTIONS

Date of Inspection: 1/1/25
Year Built: Size:
Weather:

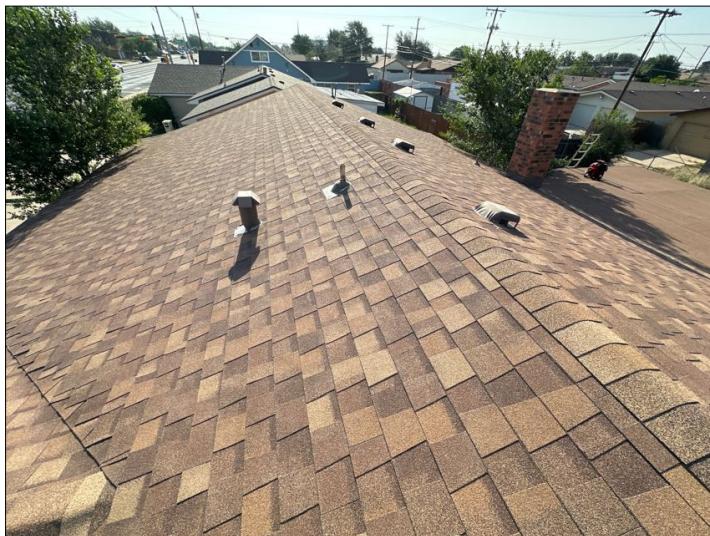
roof in generally good condition

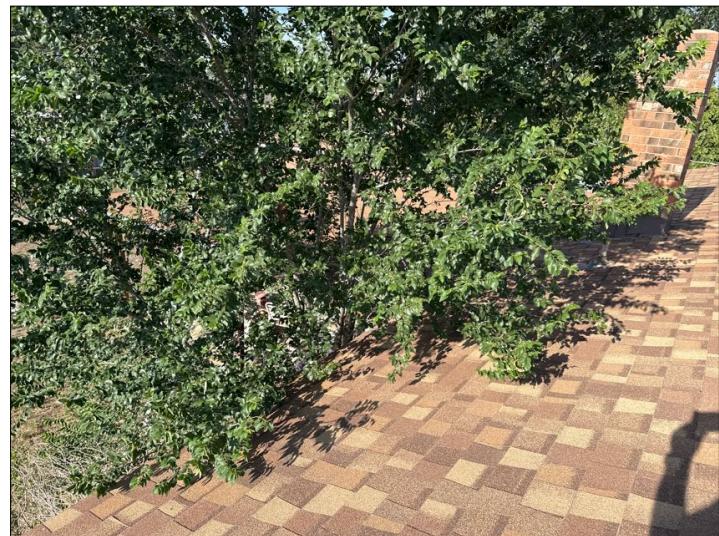
keep limbs trimmed back from roof

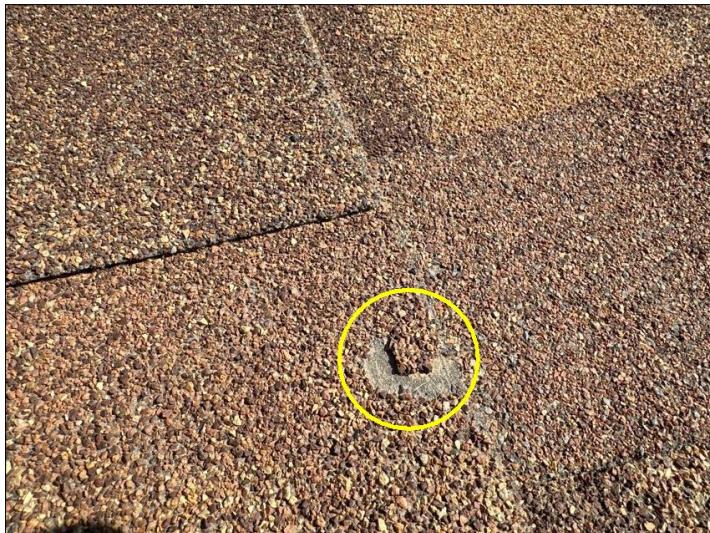
- Noted localized granule loss and/or shingle blistering. Recommend spot repair.
- Recommend keeping trees trimmed back to prevent limbs from causing shingle damage/abrasions.
- Noted one or more shingles with under-driven fastener(s). Recommend the nails be flushed and shingle be resealed.

blistering example

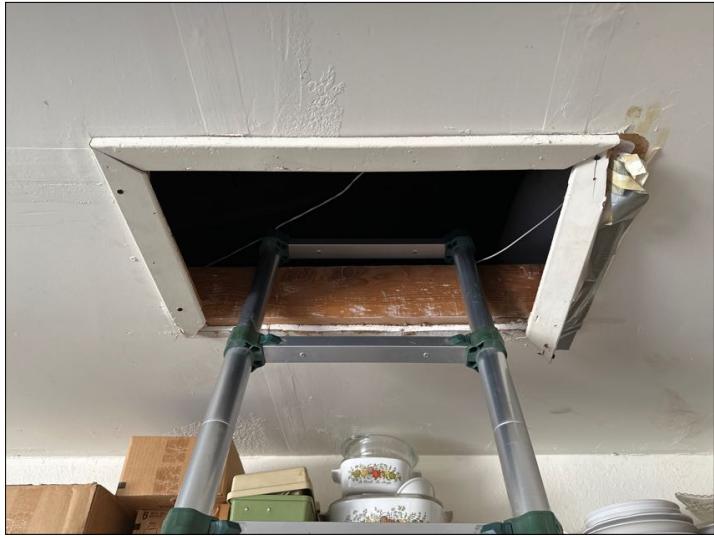
- The framing/trim that supports the attic access cover is loose. Recommend this be resecured.
- The insulation levels are lower than modern standards and one or more voids in coverage were noted. The homeowner may consider adding loose-fill insulation to improve the home's comfort and efficiency.

attic hatch damaged

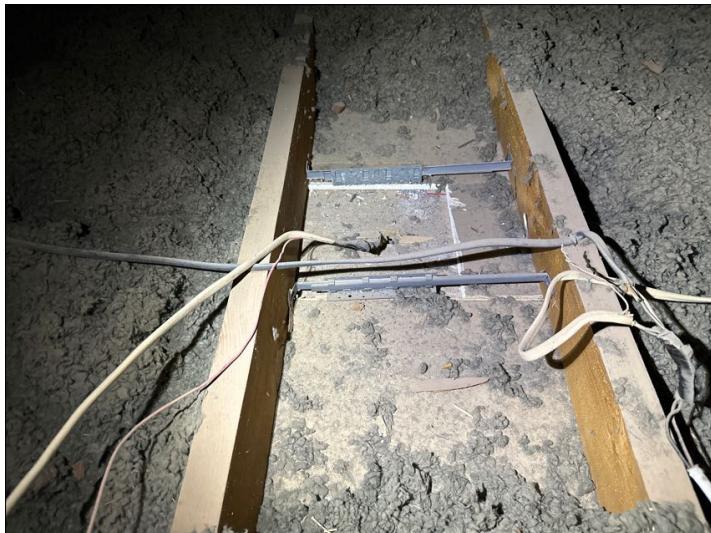
insulation missing/low example

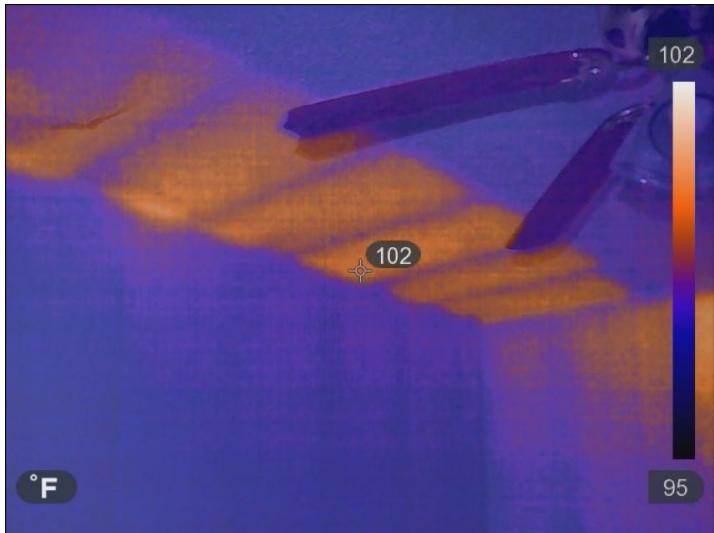
insulation missing/low example

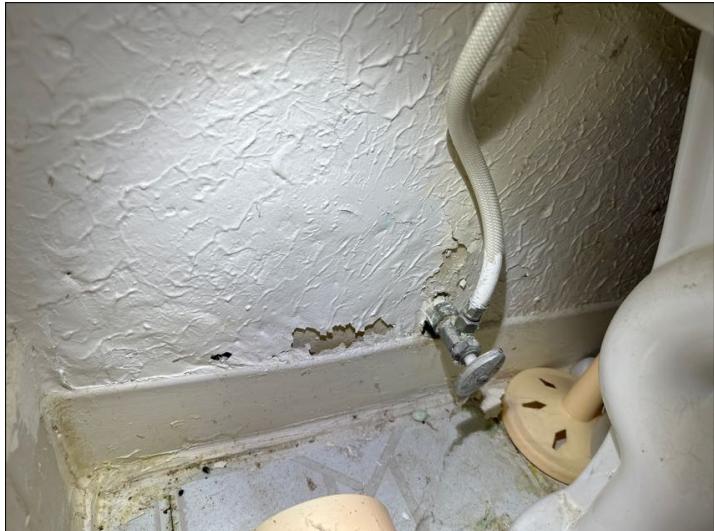
*previous water damage example*

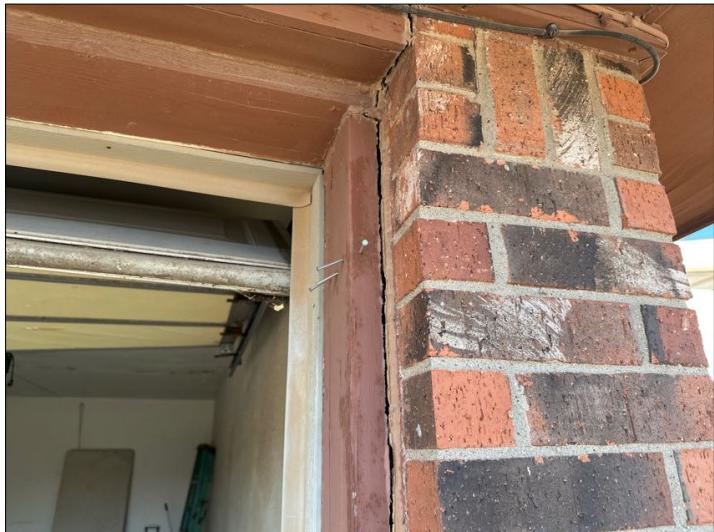
*seal ALL transitions*

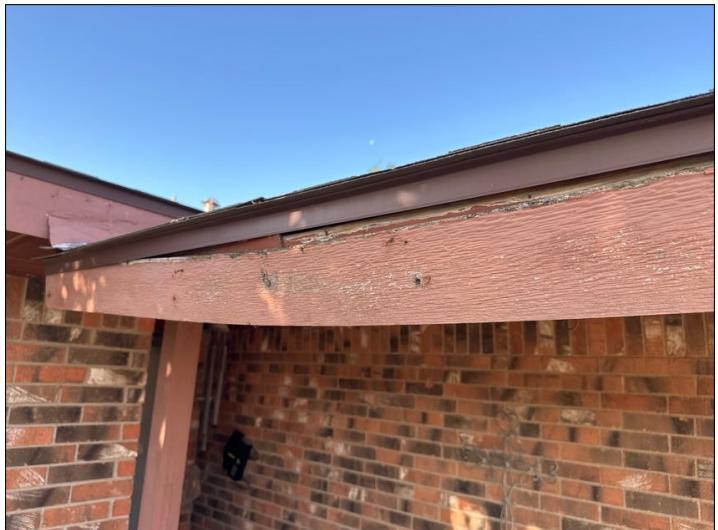
water damaged fascia example

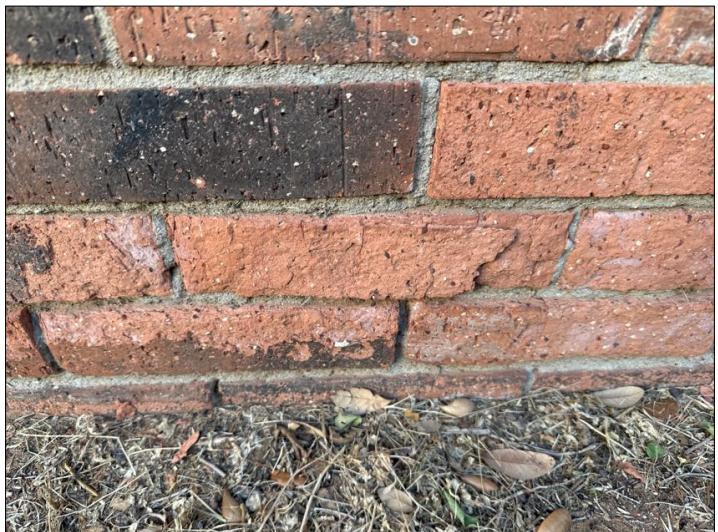
- Noted one or more areas with brick spalling/deterioration. This typically indicates an area of repeated wetting and drying of the brick.
- Interior drywall cracks and/or damage were observed in one or more areas.

brick spalling example

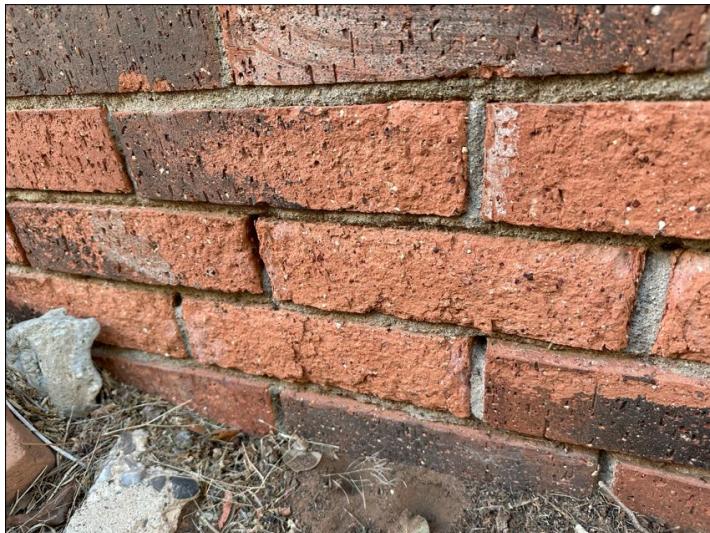
*brick spalling example*

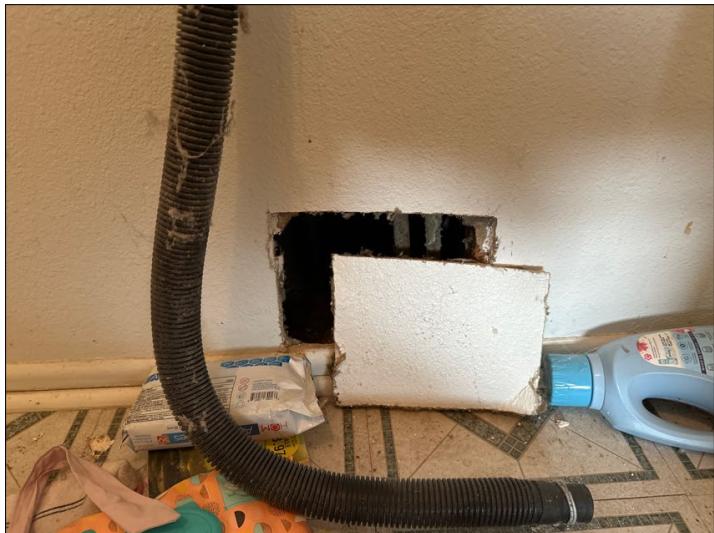
*wall exposed/missing drywall*

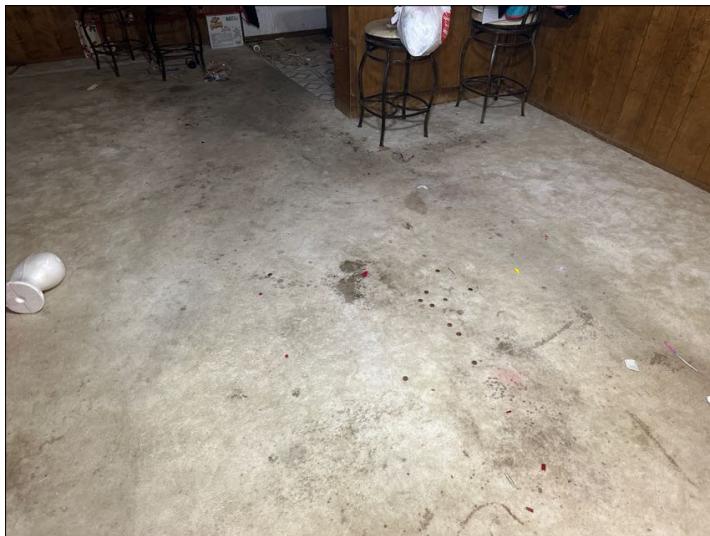
*general staining example*

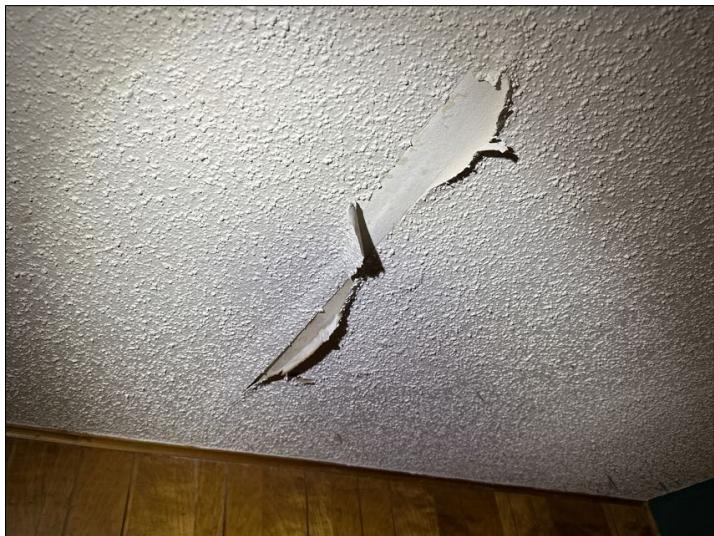
*previous water damage example*

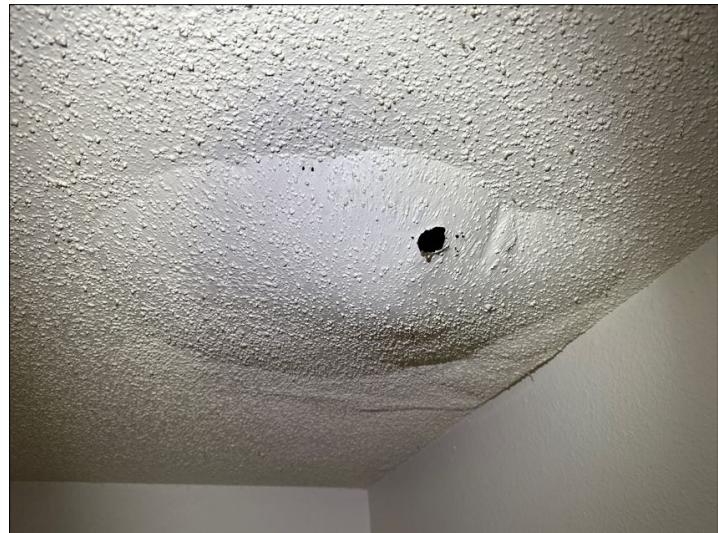
previous water damage example

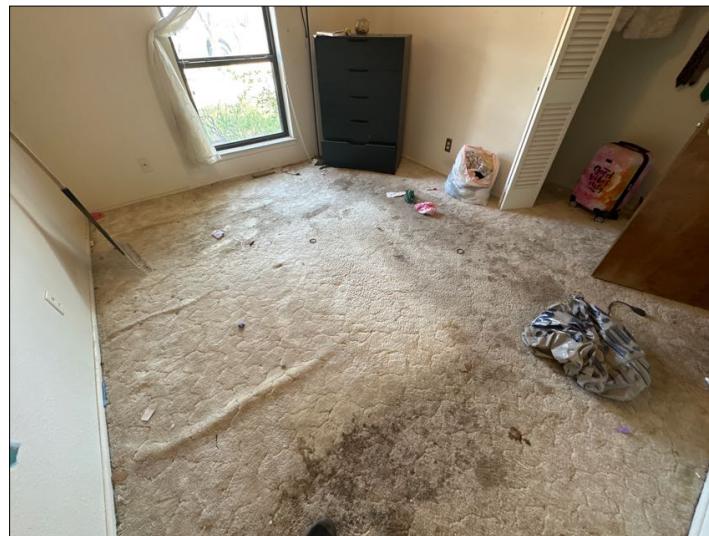
general staining/wear example

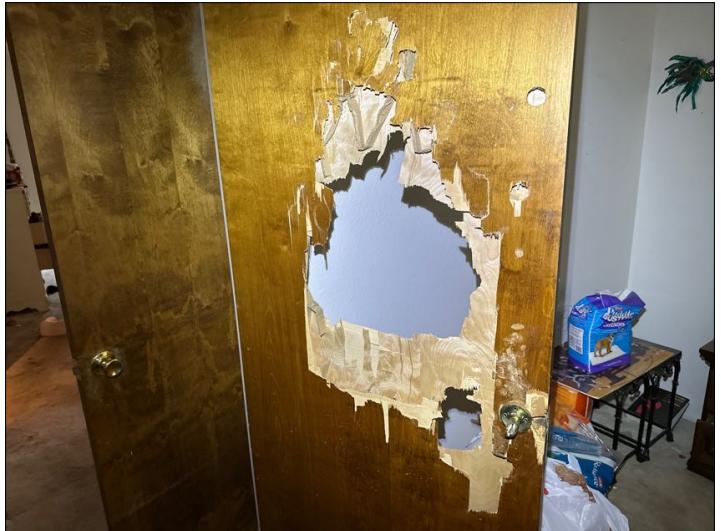
*replace damaged door*

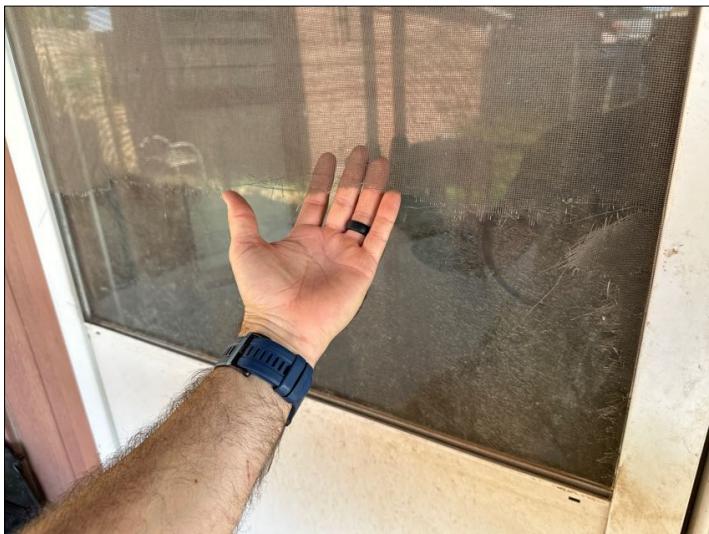
*damaged storm door screening*

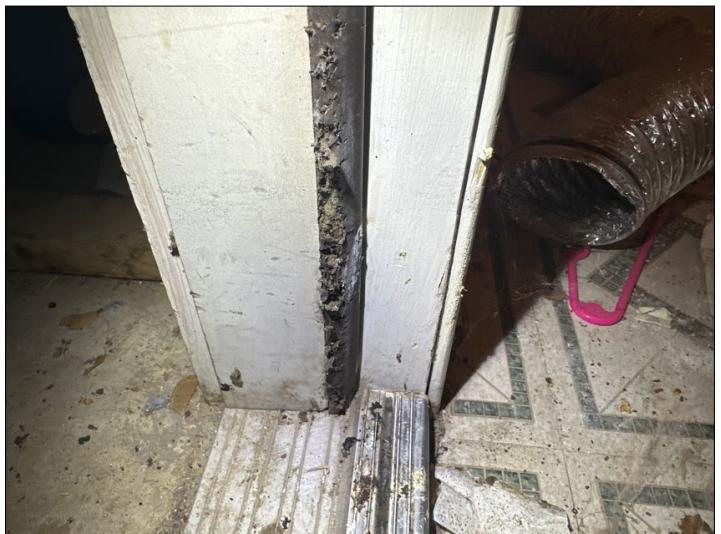
*weatherstrip damaged/missing*

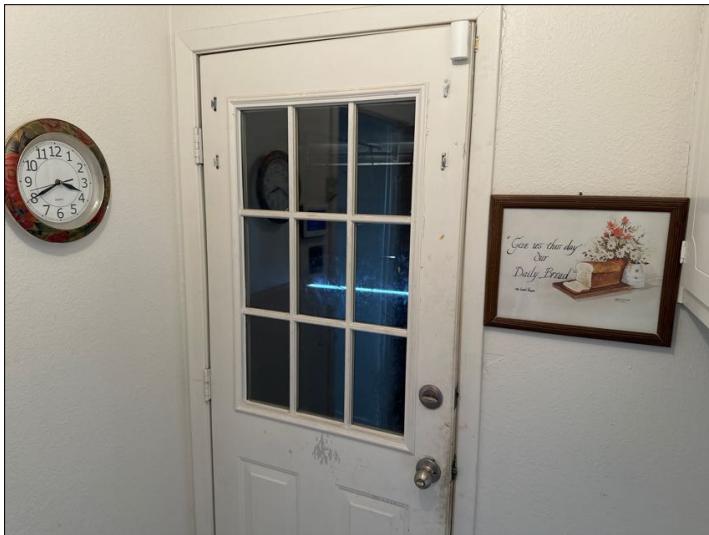
sticking door example

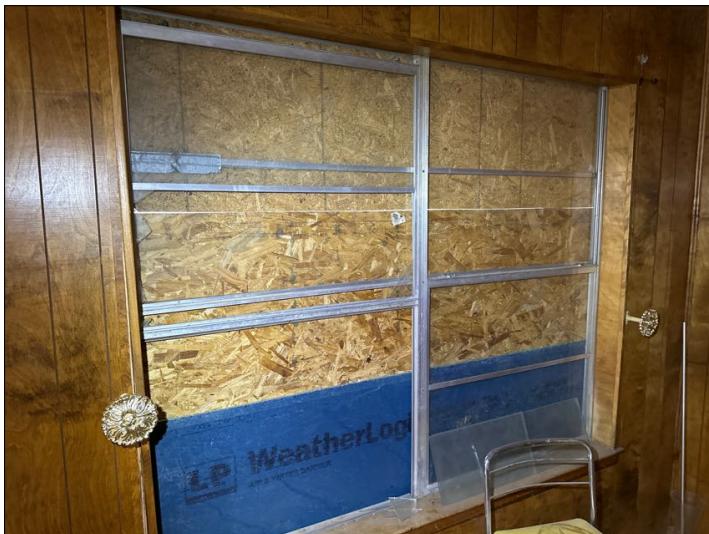
busted out window panes

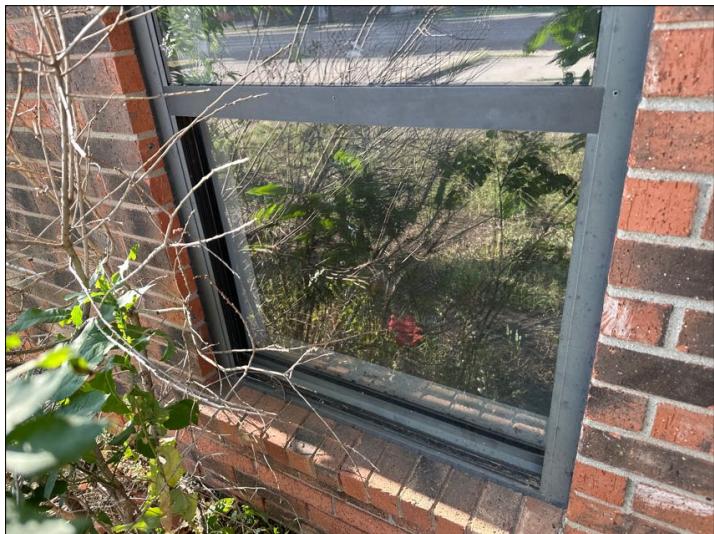
screen(s) damaged/missing

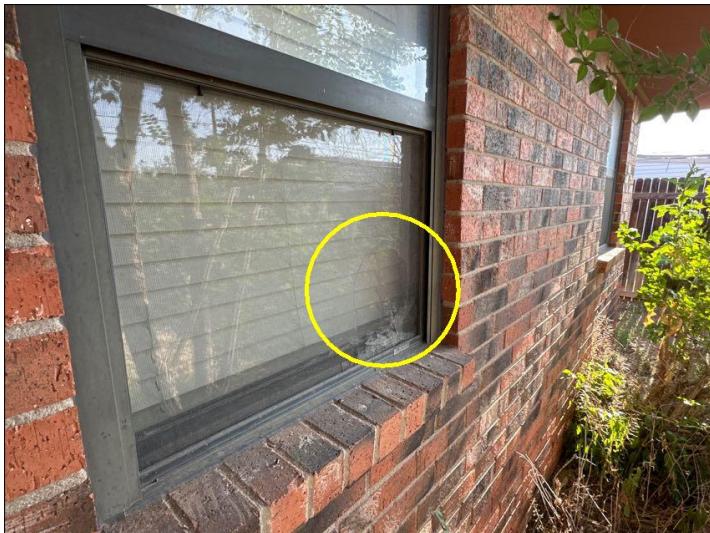
broken window

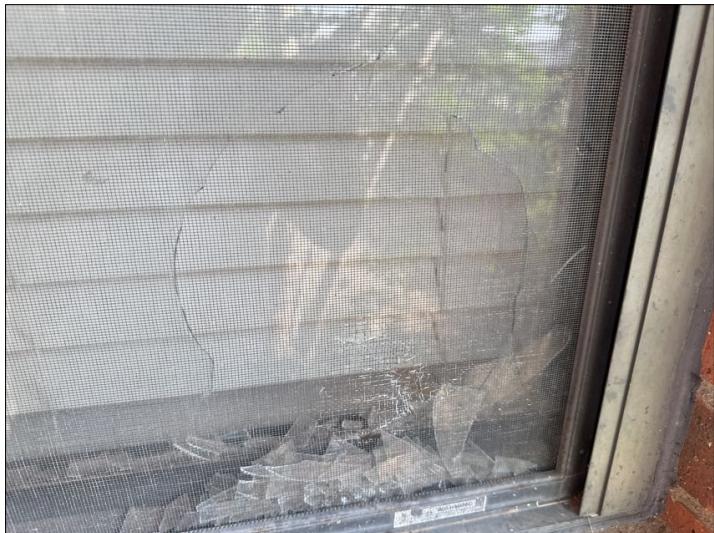
broken window

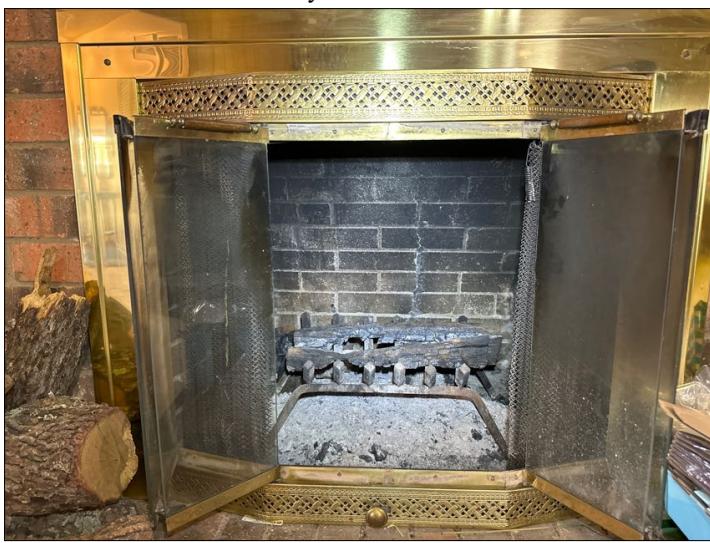
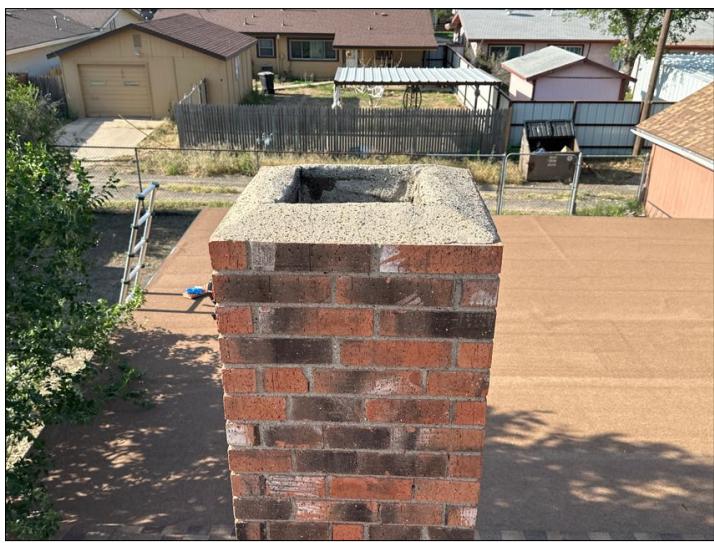
recommend spark arrestor/rain cap

- Recommend the addition of a chimney cap and/or spark arrestor to help prevent vermin and moisture intrusion
- The chimney flue should project above the mortar cap/crown (typically 1-2") to help prevent moisture entry.

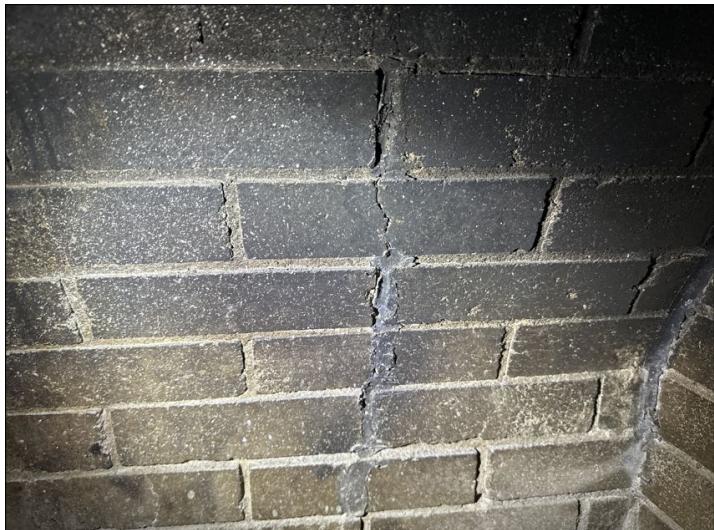
minor crack(s) in fire brick

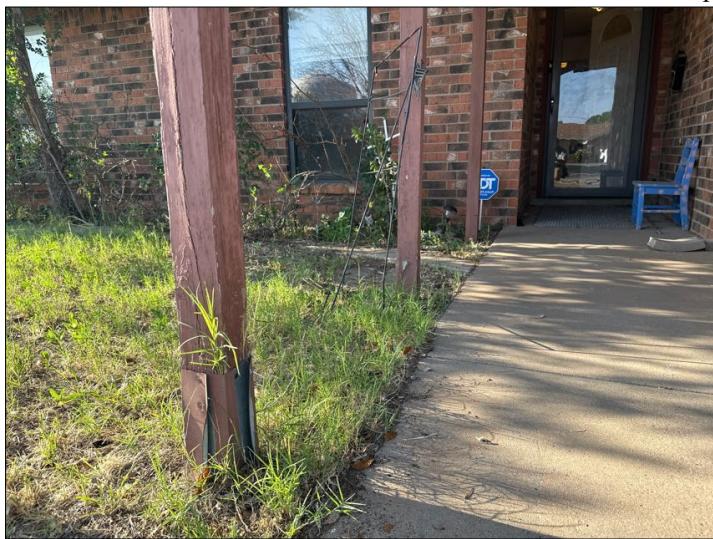
- The wood posts supporting the porch are built on grade. It is not recommended for wood to make ground contact as this promotes wood rot/deterioration. Recommend a qualified contractor add a 1" standoff base/bracket or similar device.
- The covered back porch structure is mounted to the eaves of the house. Roof eaves are not intended to bear a structural load and additional supports may be considered.
- Noted a surface crack/spalling on the porch. This typically results where rebar was installed too close to the surface of the concrete. Recommend patching.

recommend standoff brackets/bases

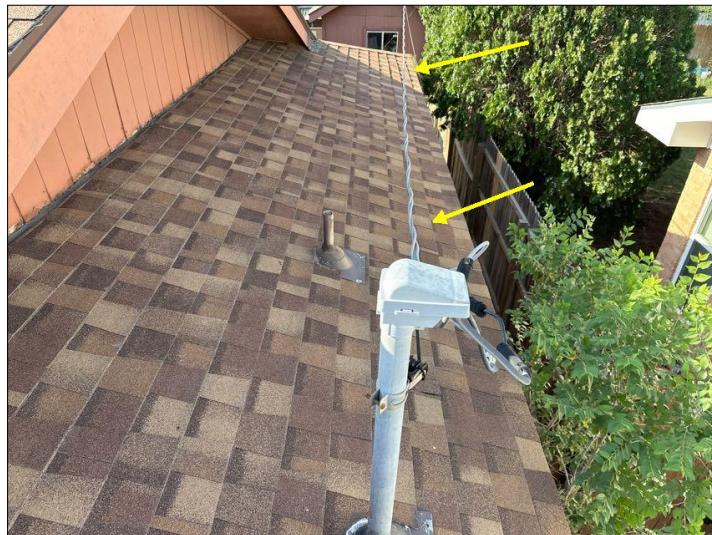
- The electrical service wires do not have proper clearance above the roof according to modern building codes. Because more than 6' of wire crosses the roof, the wires should be installed so as to be no lower than 3' off the roof.

insufficient roof clearance per modern standards

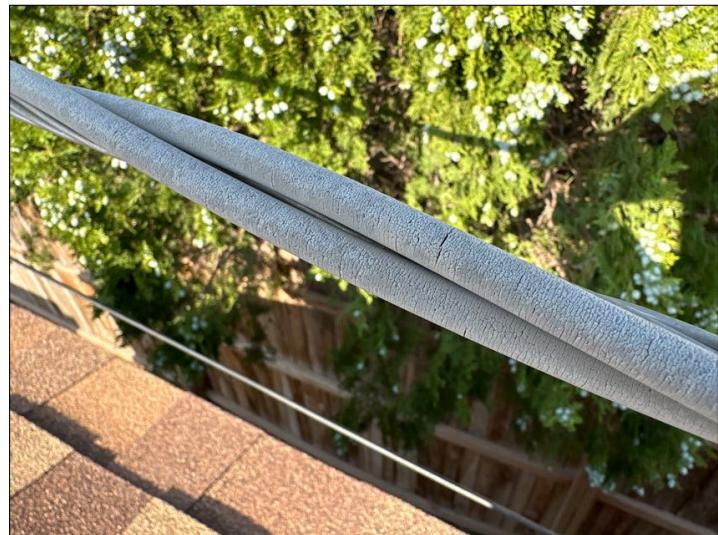
cracks/wear on sheathing of overhead cables

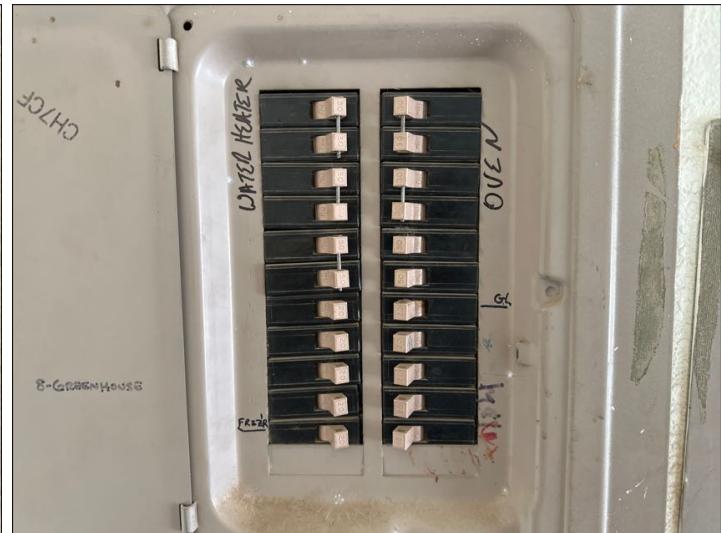
sharp-pointed screws not approved

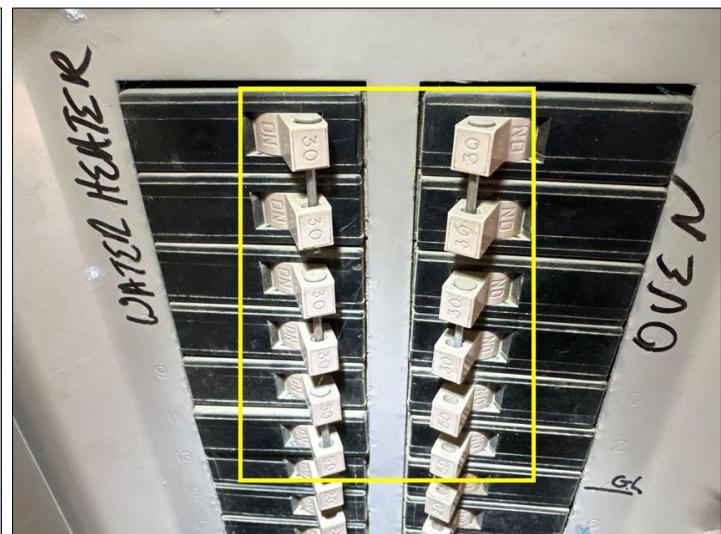
- The trip ties on the double pole breakers in the subpanel were not an approved tie material (they were nails, etc.)
- One of the screws that secure the subpanel cover in place was sharp-tipped and could possibly damage/cut wire insulation. Recommend replacement with a proper machine screw.

used nails for trip ties

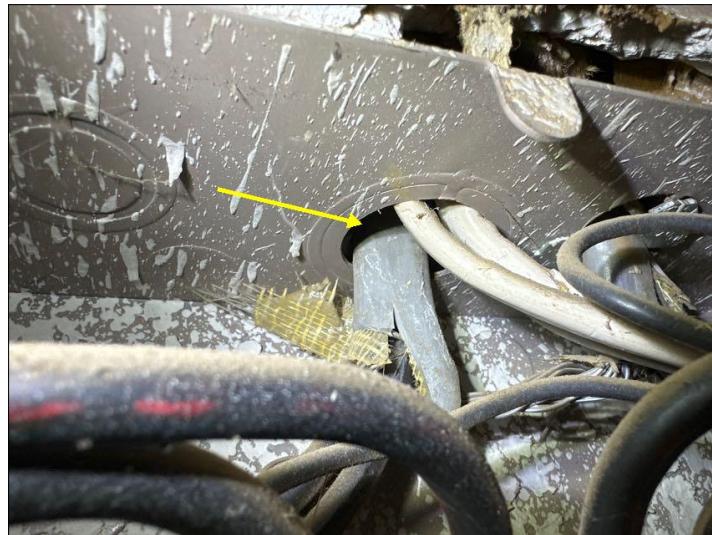
example of missing clamp/bushing

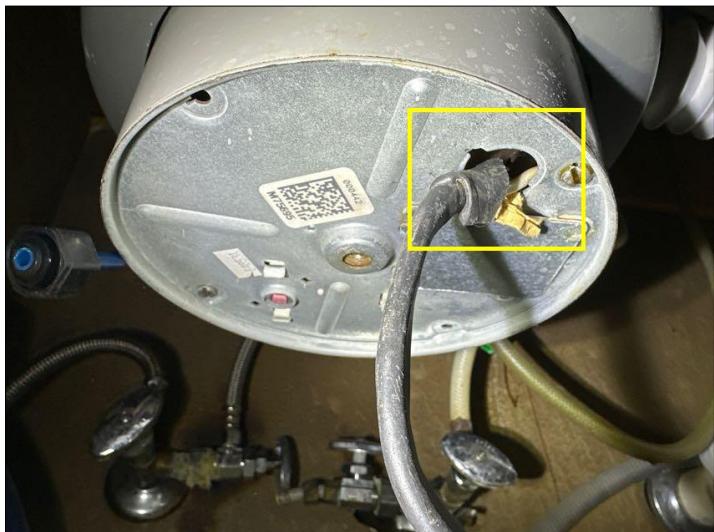
*example of missing cable clamp*

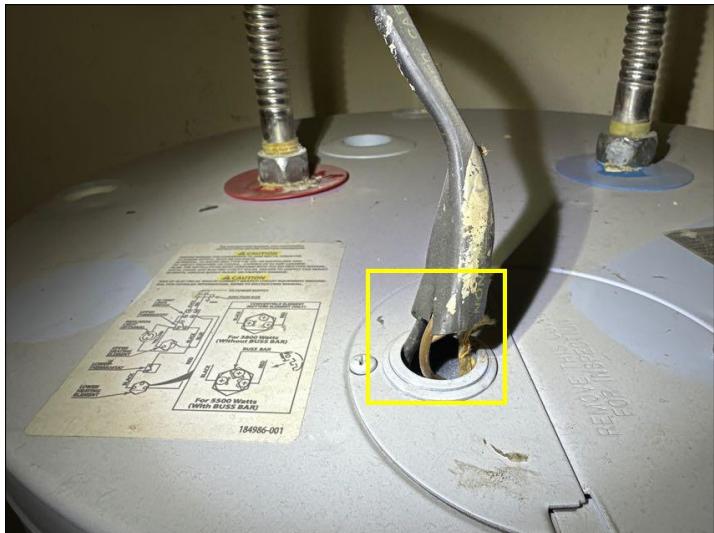
example of missing cable clamp - water heater

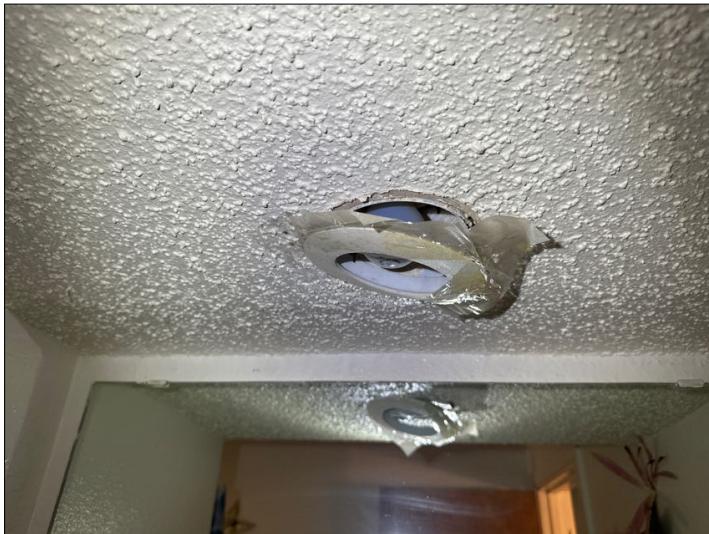
loose light fixture cover

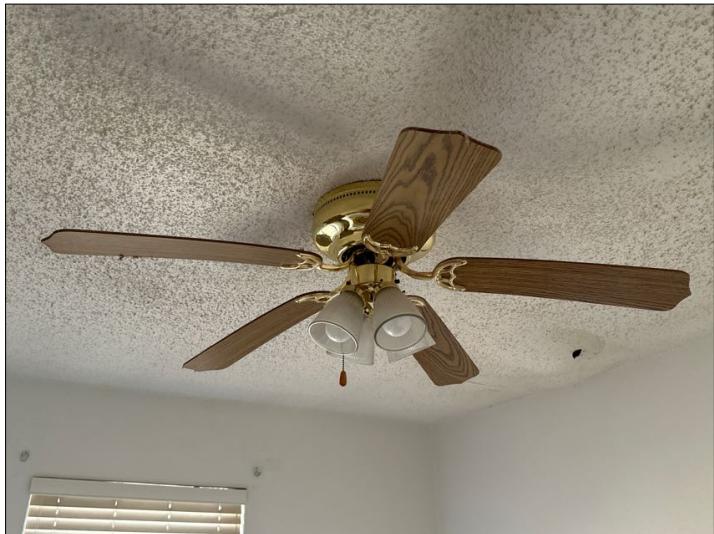
inoperable bedroom fan

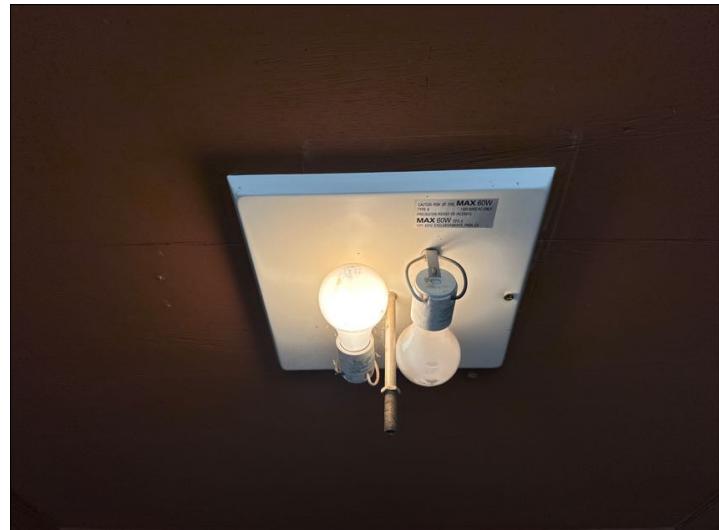
*missing fixture cover - front porch*

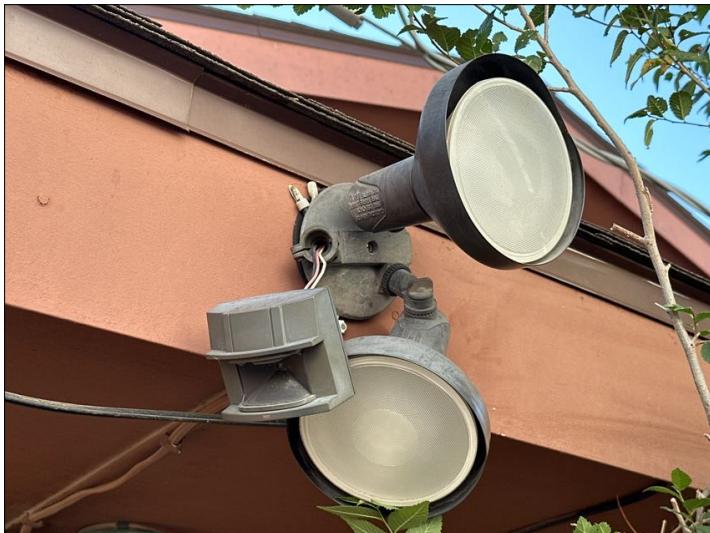
*damaged security light*

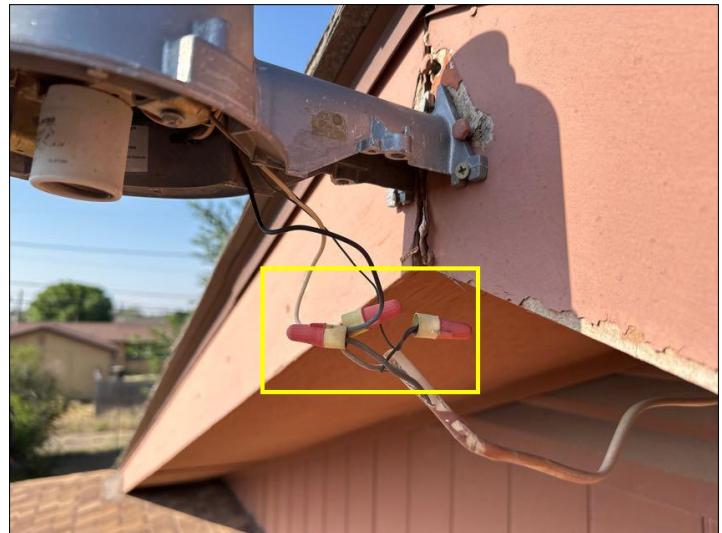
*example of open splice*

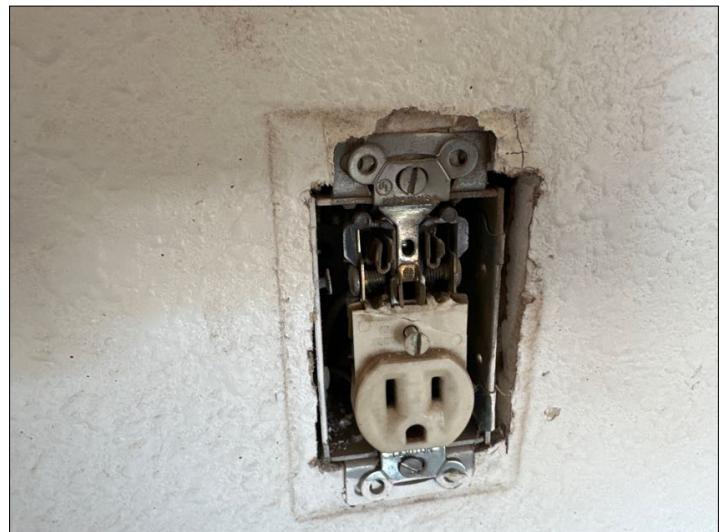
*replace damaged receptacle in garage*

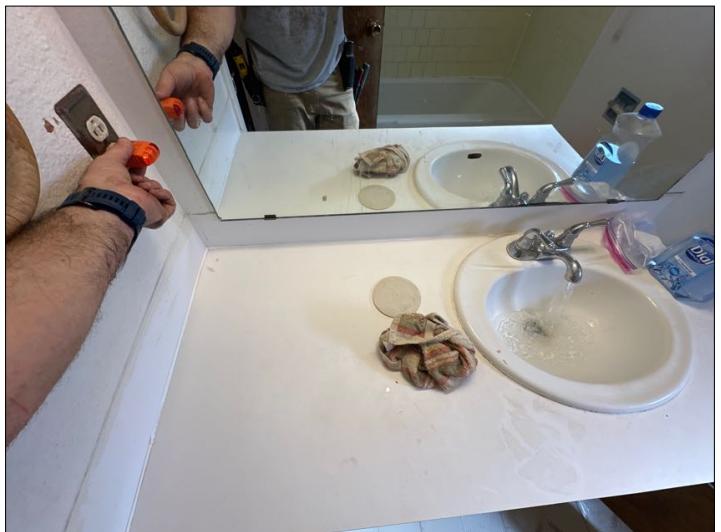
*recommend GFCI in bathroom(s)*

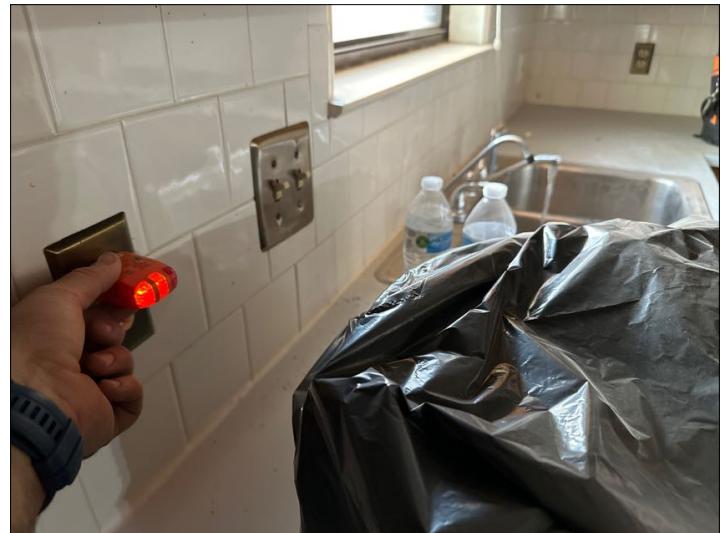
recommend GFCI in kitchen

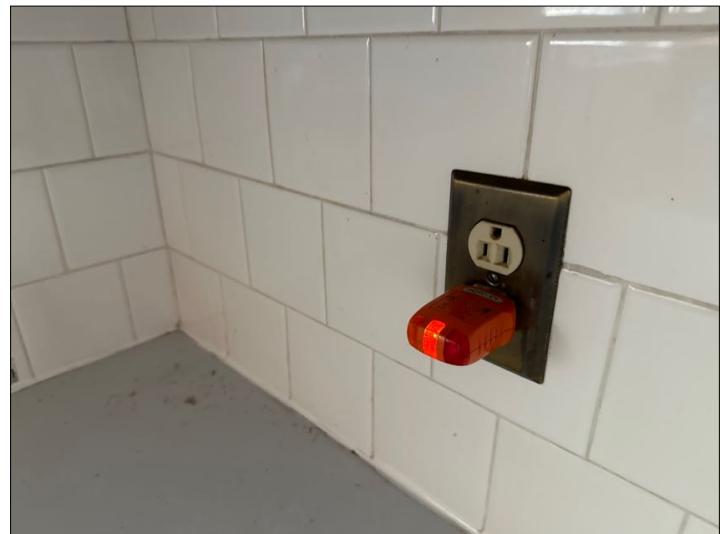
open ground receptacle in kitchen

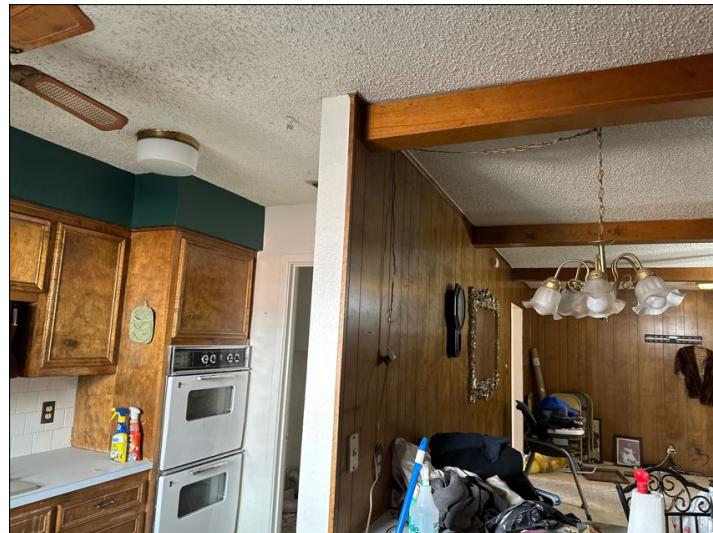
some fixtures NOT turning on

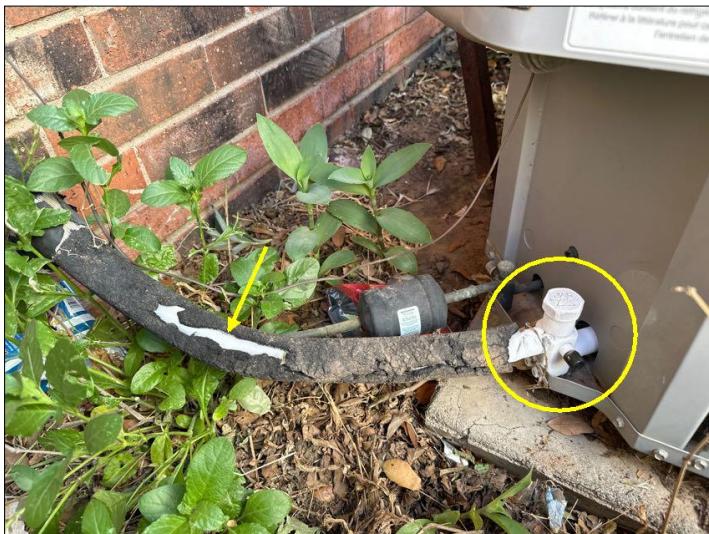
- The refrigerant line (suction line/larger line) is missing insulation in one or more areas. Where insulation is missing, the line will sweat. Refer to picture(s).
- The refrigerant lines were observed to be freezing/frozen. This can be due to an air restriction, low refrigerant charge, etc. Recommend an HVAC contractor for evaluation and repair.

unit froze up upon operation; recommend further evaluation

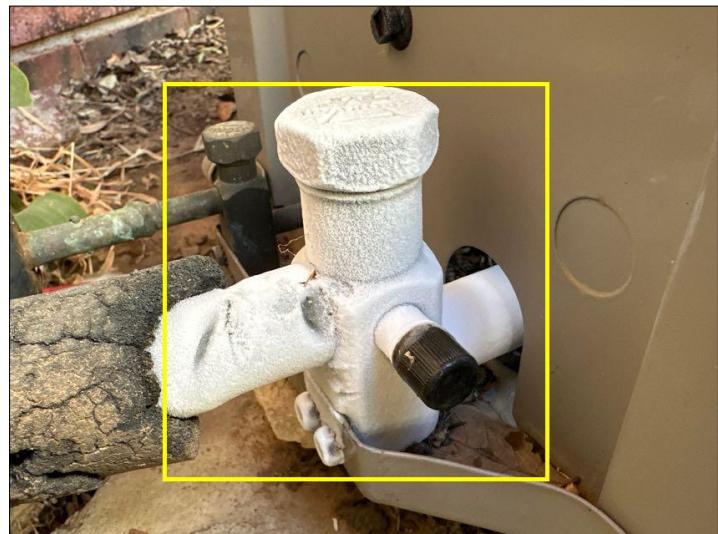
unit froze up upon operation; recommend further evaluation

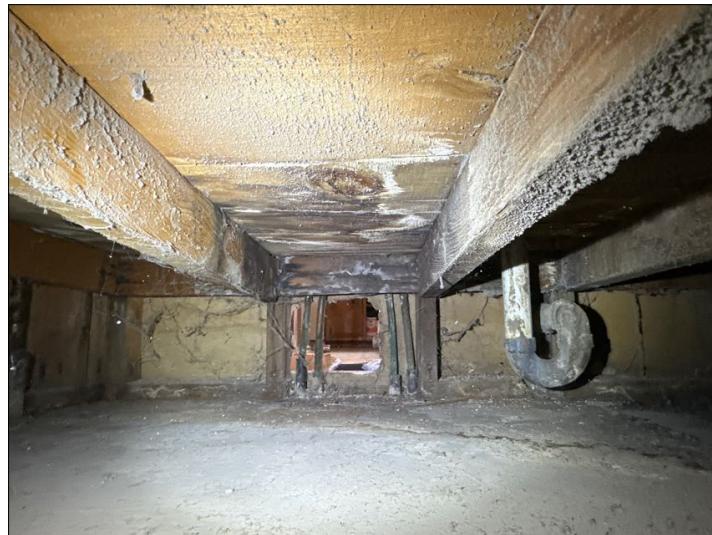
*previous water damage in return air chase* **D. Other**

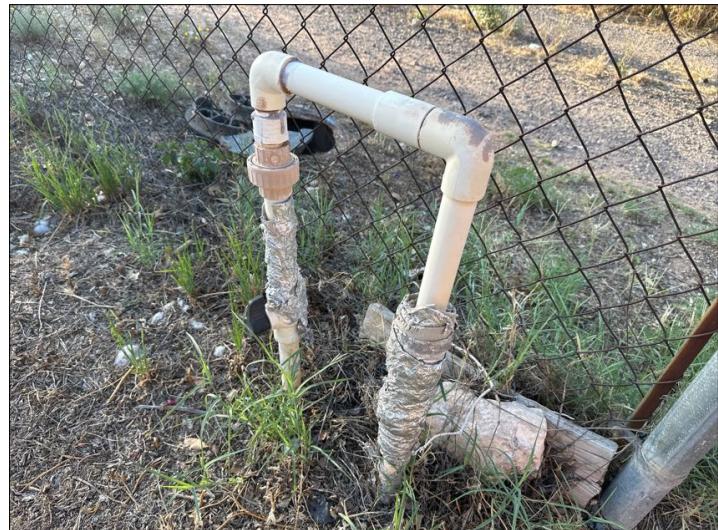
*insulate piping*

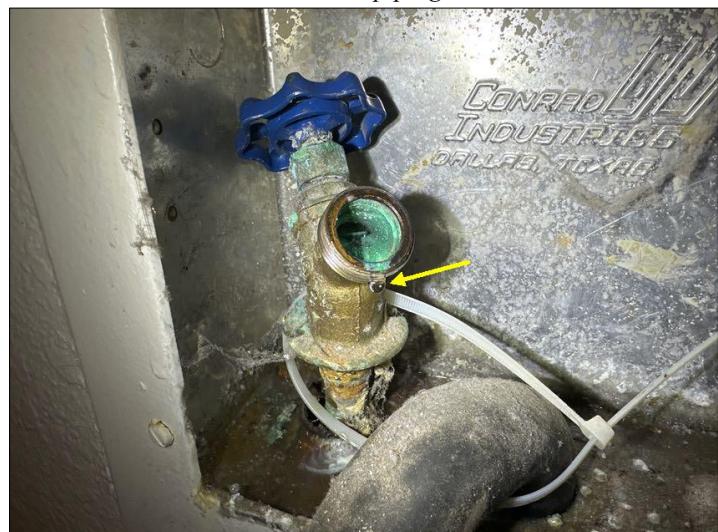
*dripping/slow leak from laundry hose bibb connections*

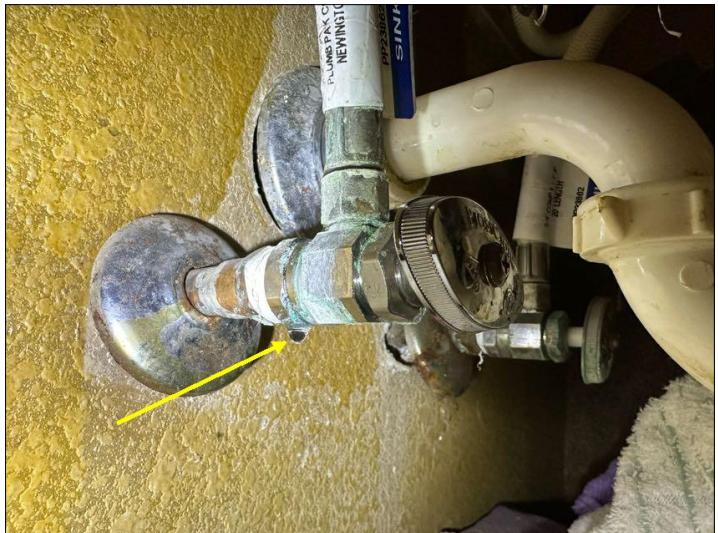
leaking faucet - master bathroom

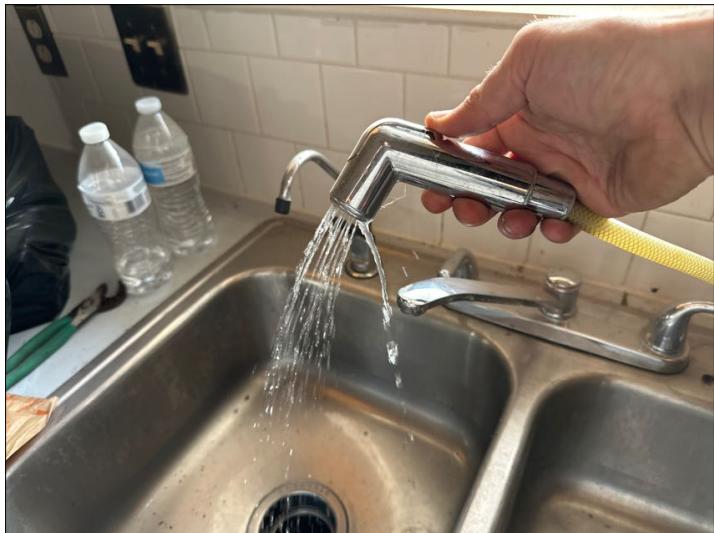
kitchen sprayer doesn't work well

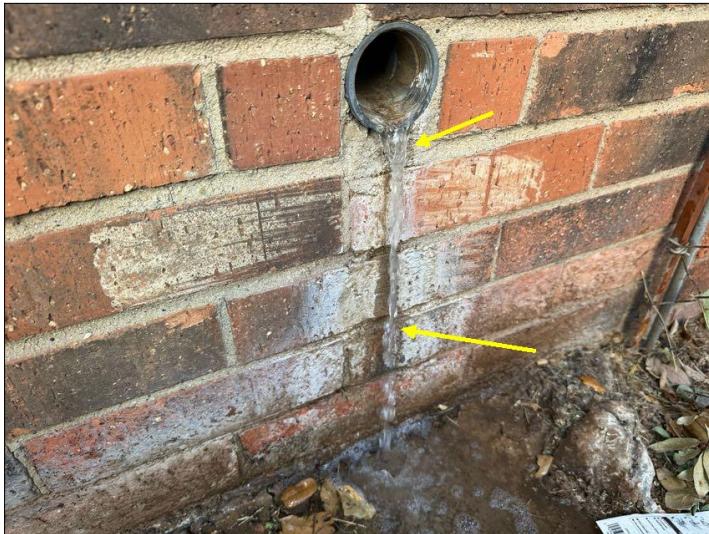
- Noted an obstructed and/or slow draining fixture in one or more areas. Recommend repair. ***the kitchen sink was backing up and draining out of the wall cleanout.
- One or more of the drains appeared to be draining slowly and should be evaluated for an obstruction.
- One or more sinks are piped with flexible/corrugated drainpipe. This product is often used by handymen and homeowners but is not actually approved and could contribute to increased blockages.
- One or more drain leaks were observed and should be repaired. Refer to picture/video

kitchen sink drains out cleanout due to blockage downstream

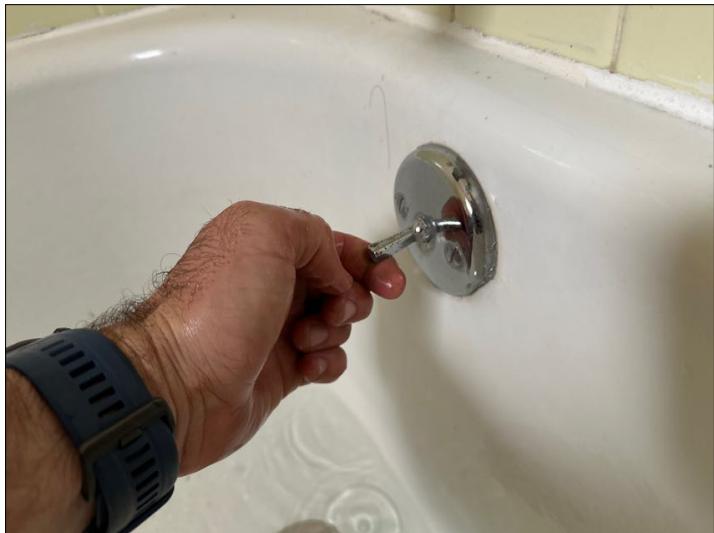
guest bath drain sticks

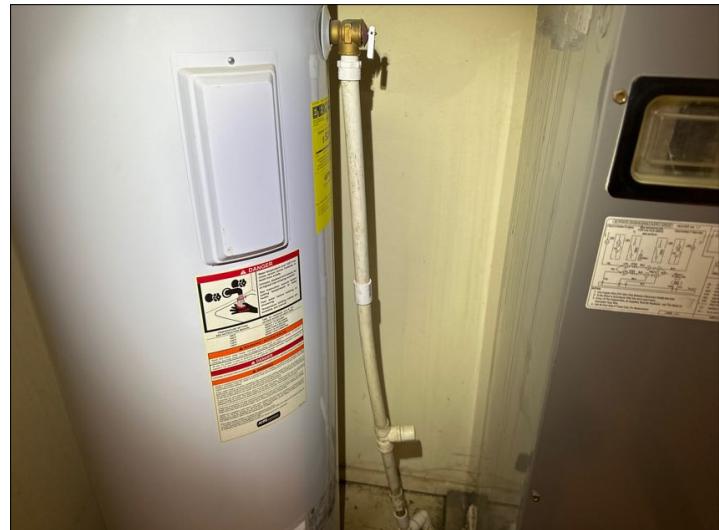
- The service disconnect for the water heater is in another room (not within a line of sight) and is not compliant with modern codes.
- PVC pipe is not approved for application as a TPR discharge line because it is not rated for heated water. Recommend connection of approved material, such as CPVC or copper be made.
- Recommend a proper catch pan/drain pan be installed.

TPR piped out with PVC

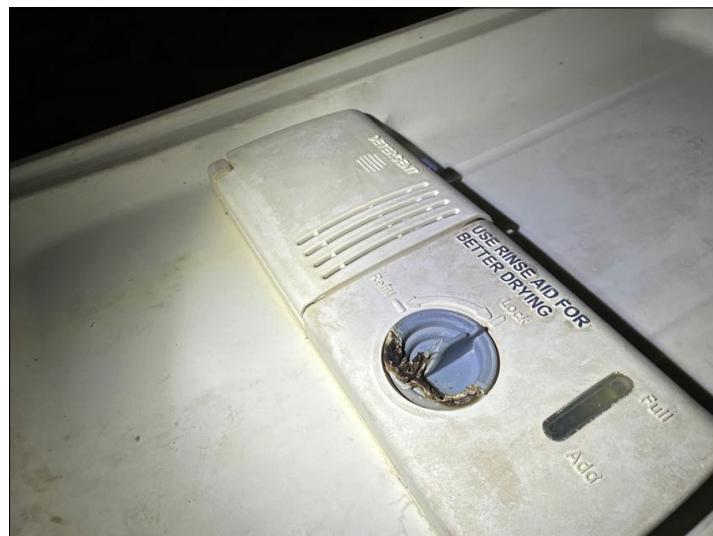
*cosmetic damage example*

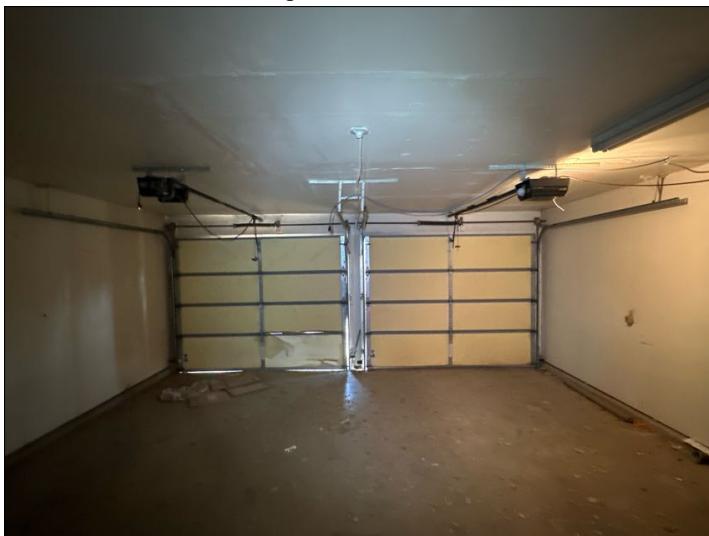
garage doors won't open via openers
