PROPERTY INSPECTION REPORT

SUMMIT
HOME INSPECTIONS

Date of Inspection: 1/1/25
Year Built: Size:
Weather:

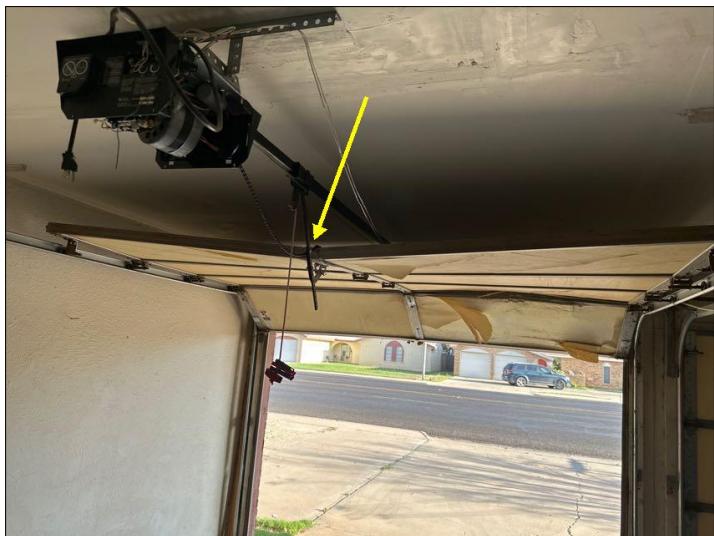
garage door damaged/bending

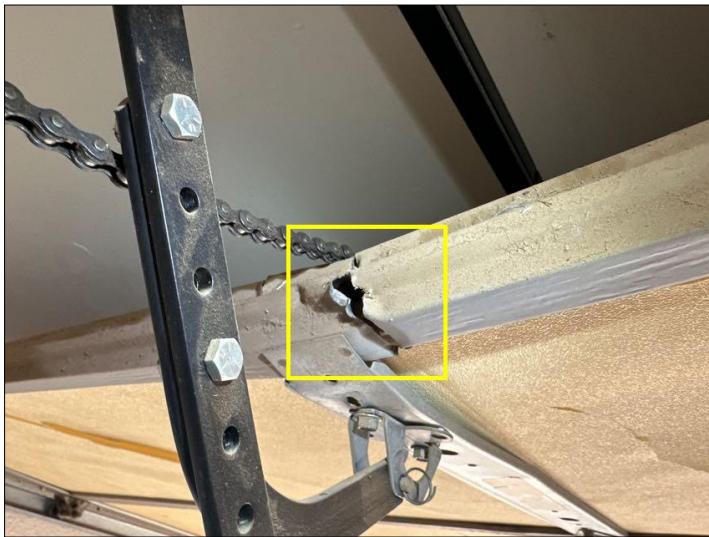
garage door damaged/bending

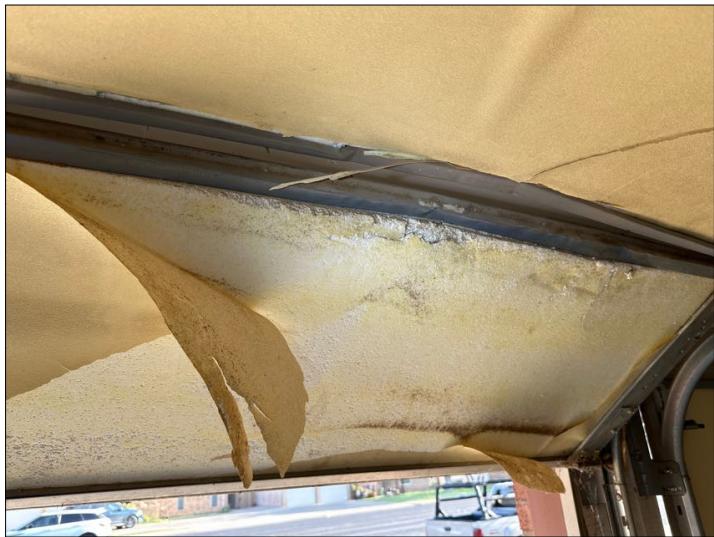
garage door damaged/bending

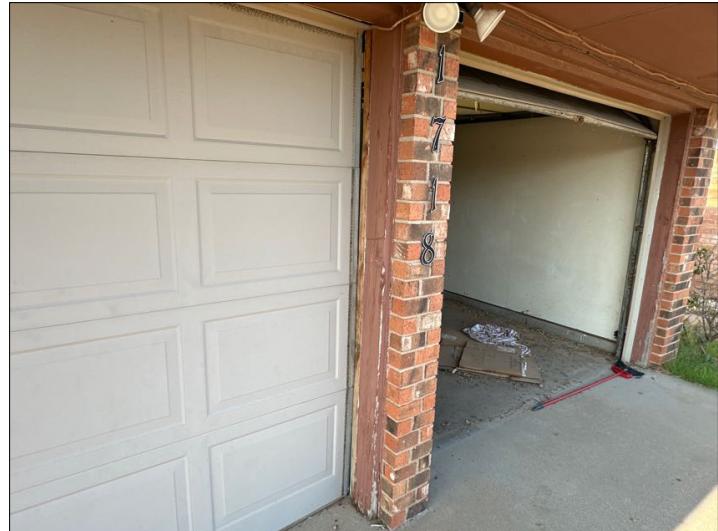
missing weatherstripping
