PROPERTY INSPECTION REPORT

SUMMIT
HOME INSPECTIONS

Date of Inspection: 1/1/25
Year Built: Size:
Weather:

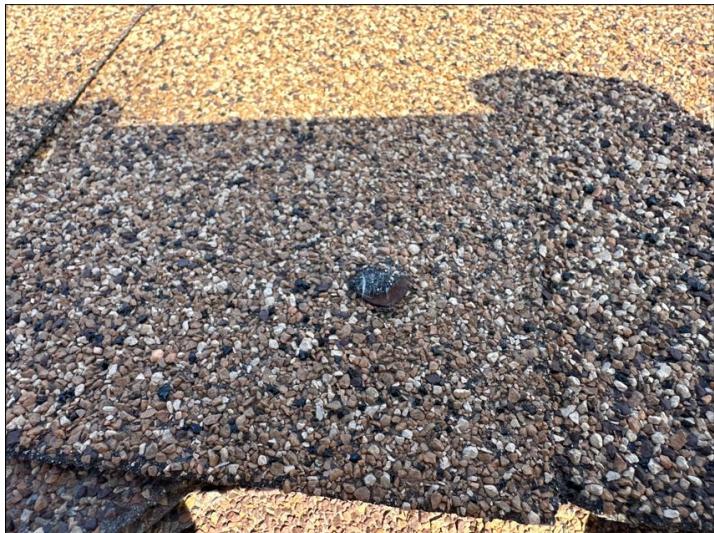
- Noted localized granule loss and/or shingle blistering. Recommend spot repair.
- Recommend keeping trees trimmed back to prevent limbs from causing shingle damage/abrasions.
- Noted one or more shingles with under-driven fastener(s). Recommend the nails be flushed and shingle be resealed.

nail pop example

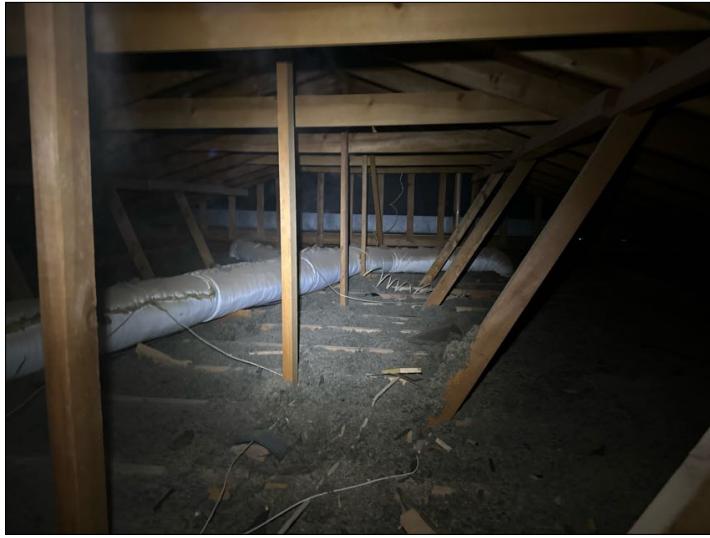
general photo

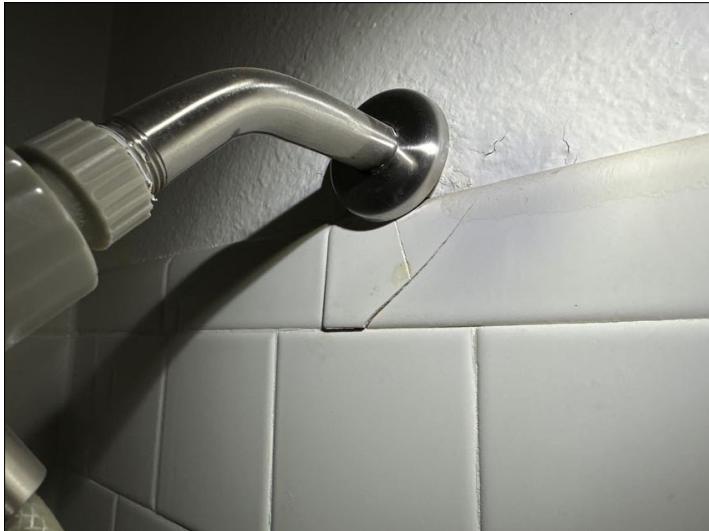
- Noted cracked wall tile in one or more areas. Refer to picture(s).
- Water damage was noted in the eaves (fascia, soffit, decking etc) in one or more areas.

*cracked tile example*

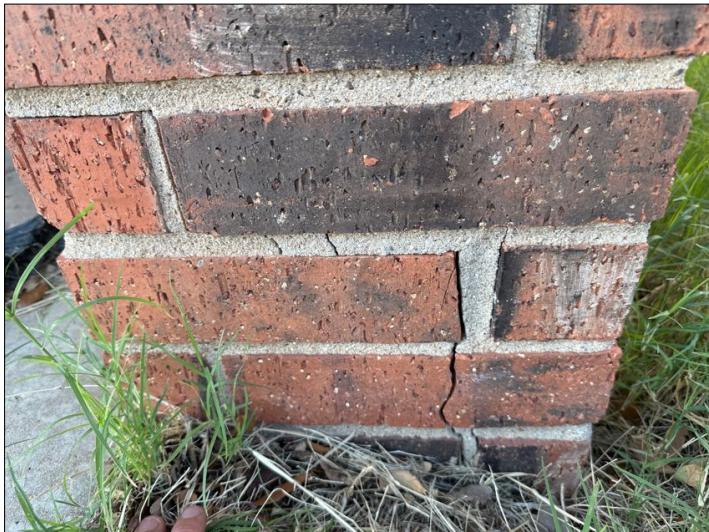
- Noted common shrinkage and/or settling cracks in the exterior veneer at one or more areas around house. This is typical of all masonry construction and is generally of no structural significance. Recommend sealing/tuck-pointing to prevent moisture intrusion.

*thermal/expansion crack example*

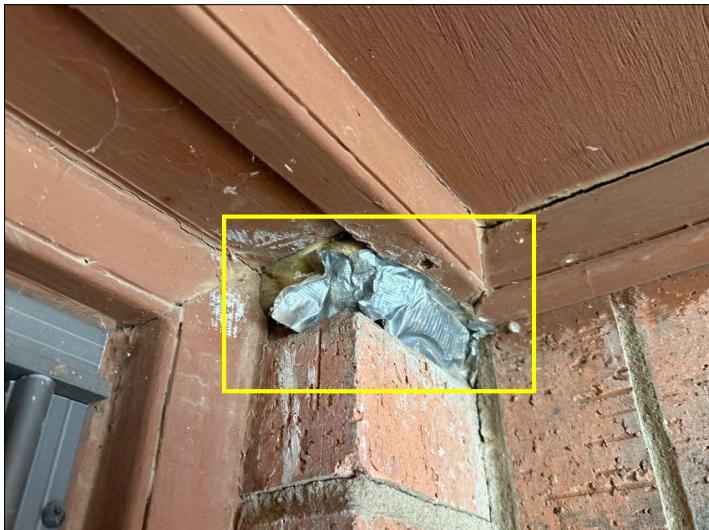
fill void

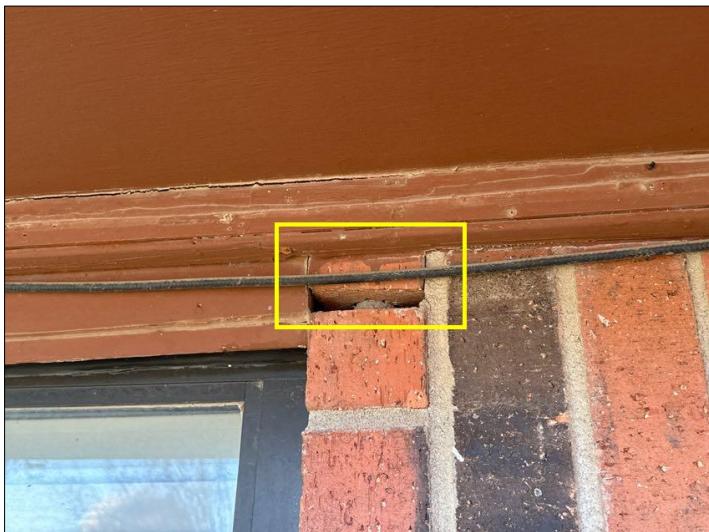
loose brick

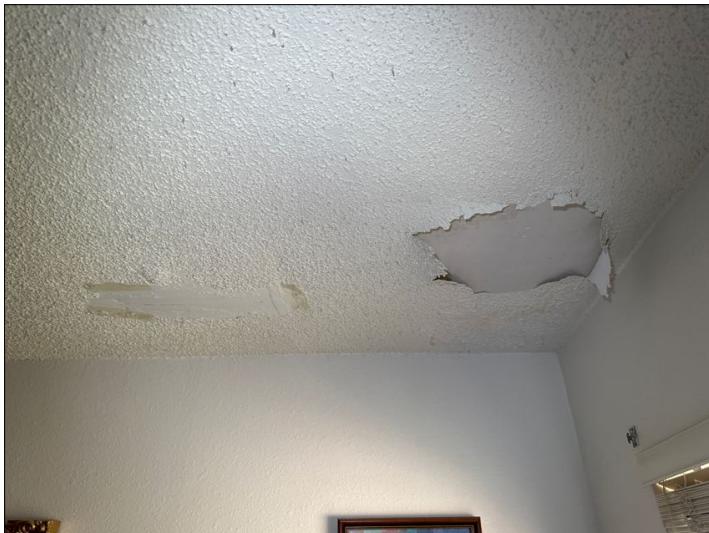
- Noted water stains/damage in one or more areas. Refer to pictures.
- WDI (wood destroying insect) damage was observed in one or more areas. A home inspection is non-invasive and thus hidden damages may exist. The client may desire an invasive inspection of the affected areas to determine the integrity of the framing etc.

previous water damage example

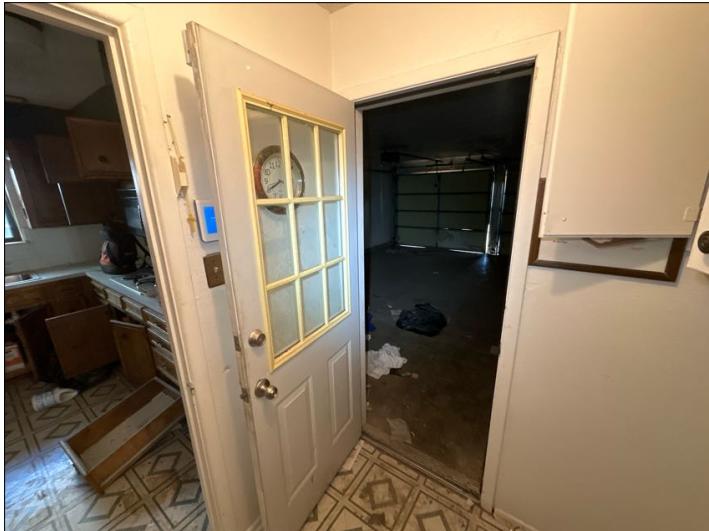
*non fire-rated, non self-close door*

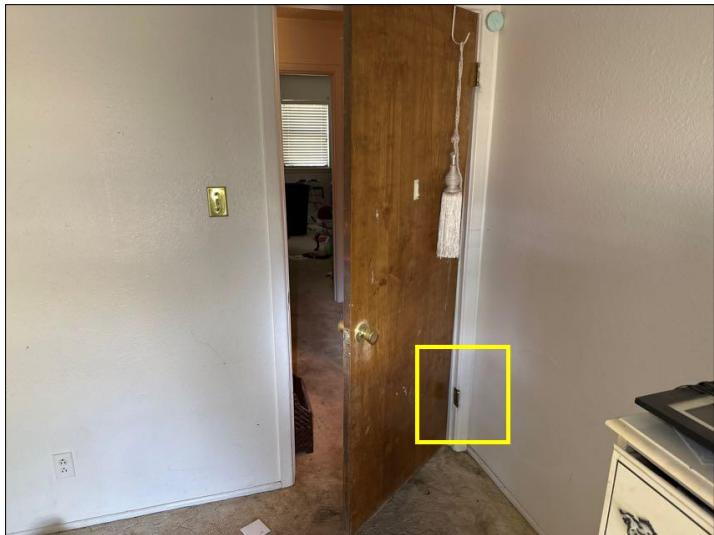
bedroom door off hinges

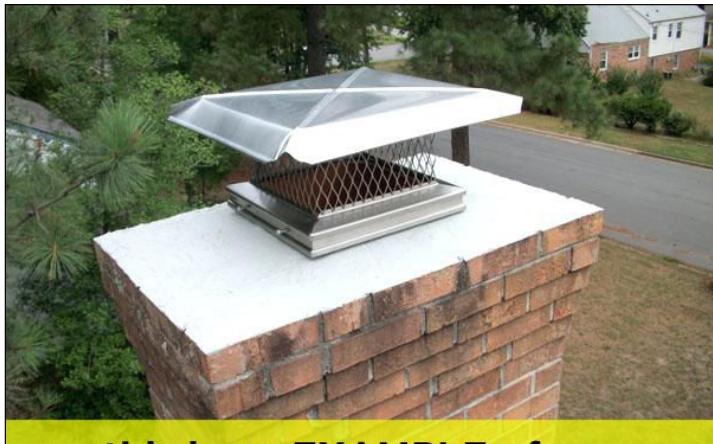
**this is an EXAMPLE of a
spark arrestor & rain cap**

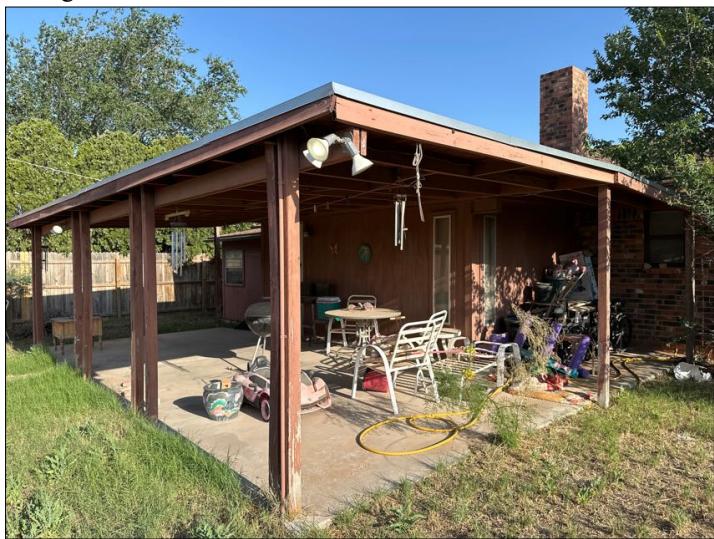
this is an EXAMPLE of
a standoff post base

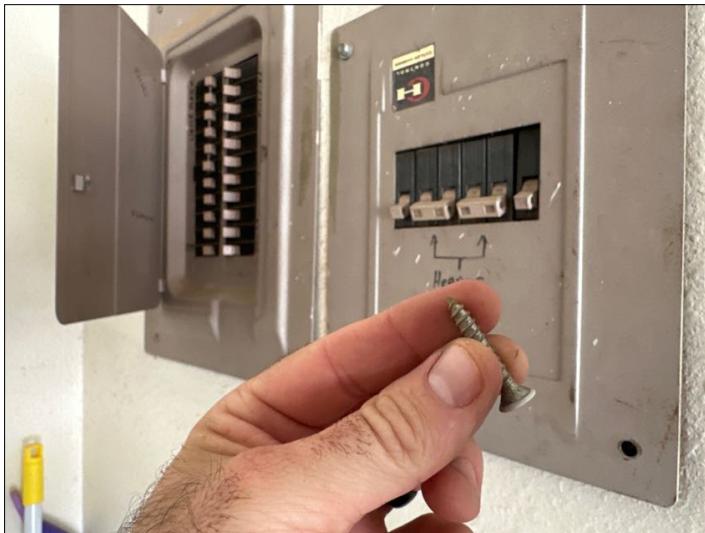
sharp-pointed screws not approved

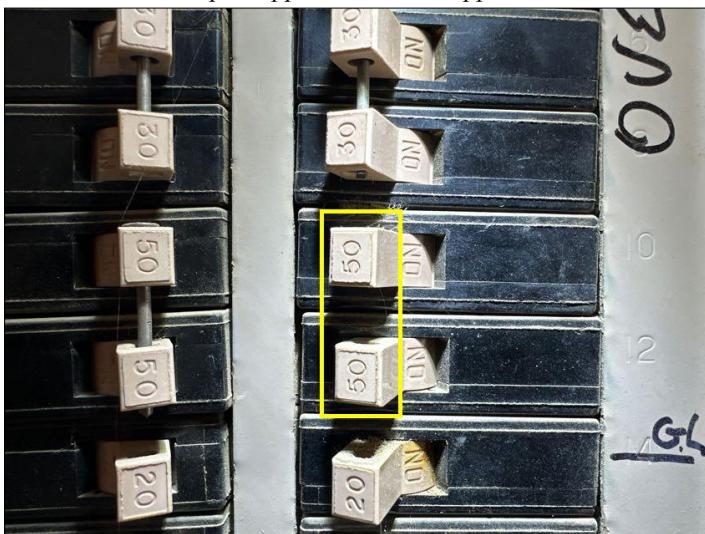
missing trip tie

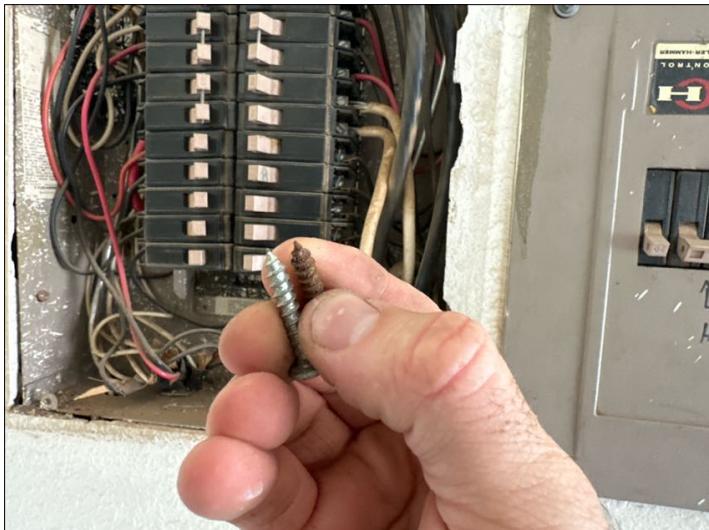
*sharped-tipped screws not approved*

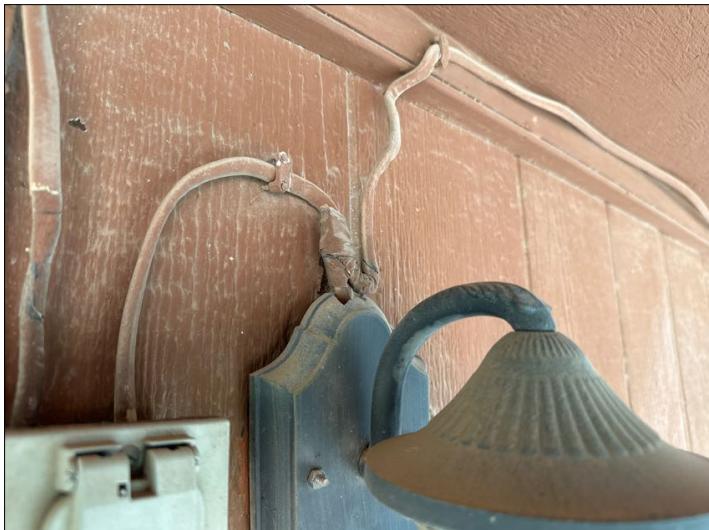
*repair open splice*

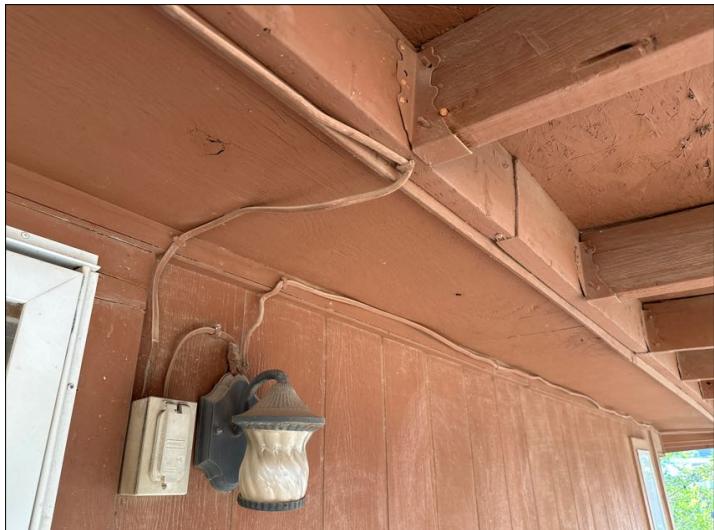
*recommend protecting electrical cables at exterior*

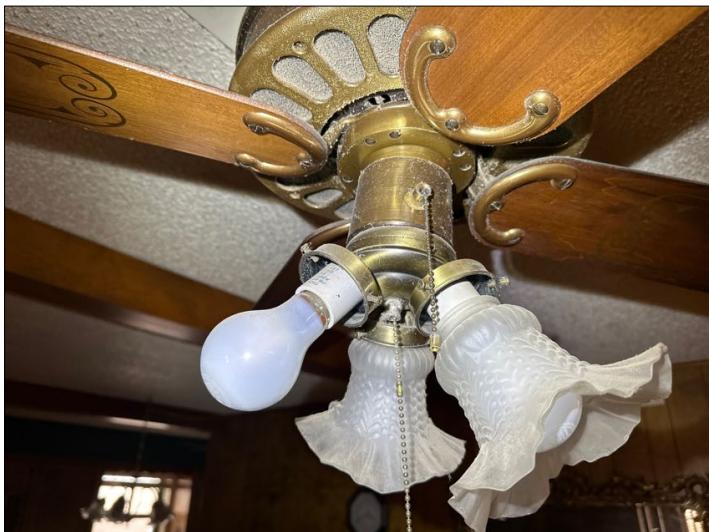
*missing fixture cover*

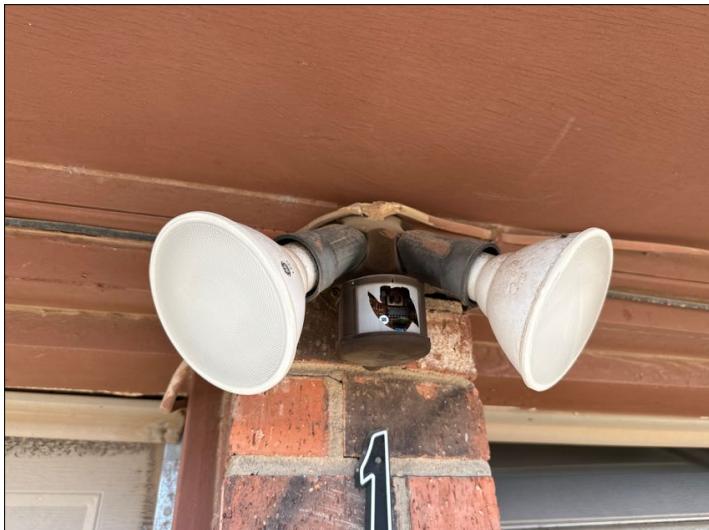
*cosmetic damage example*

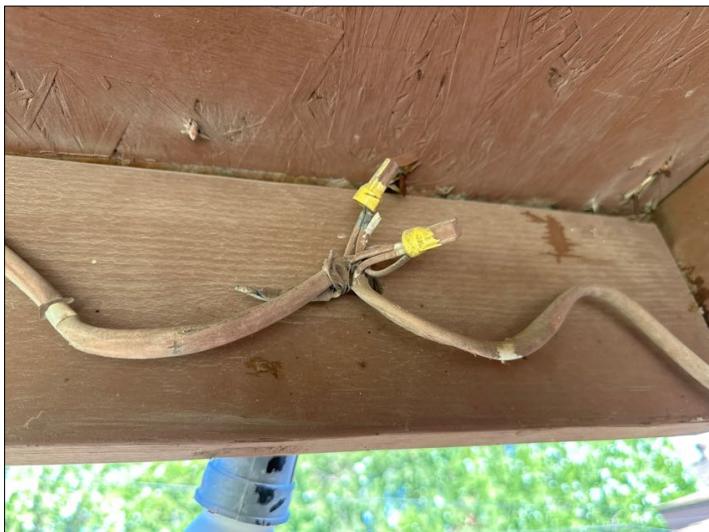
*example of open splice*

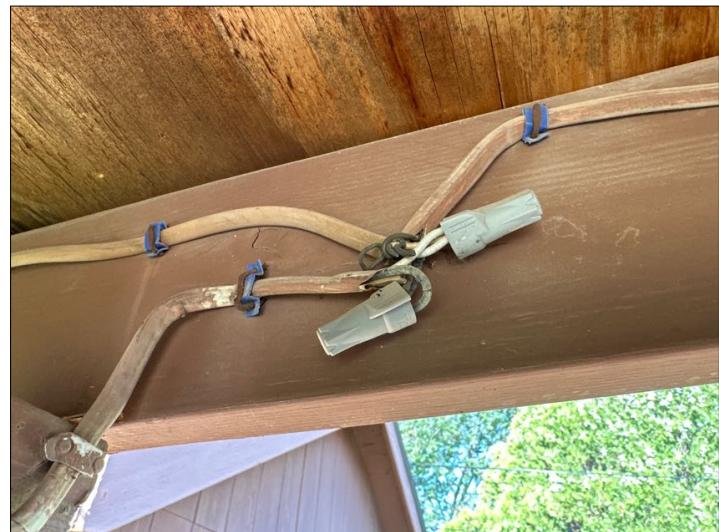
*example of open splice*

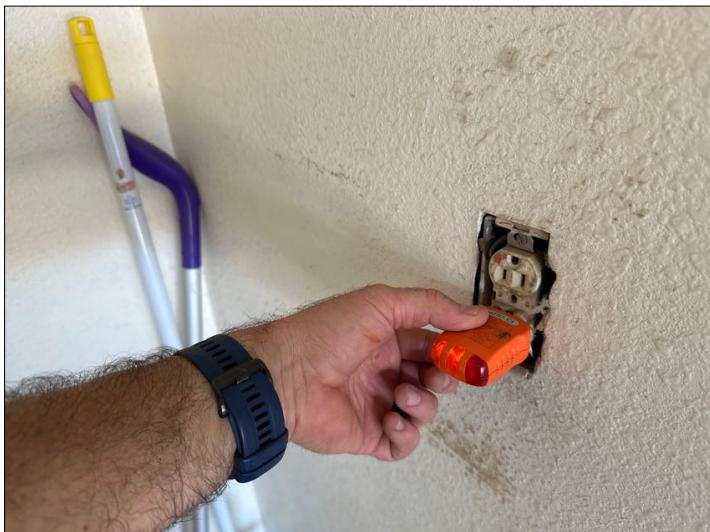
*recommend GFCI in garage*

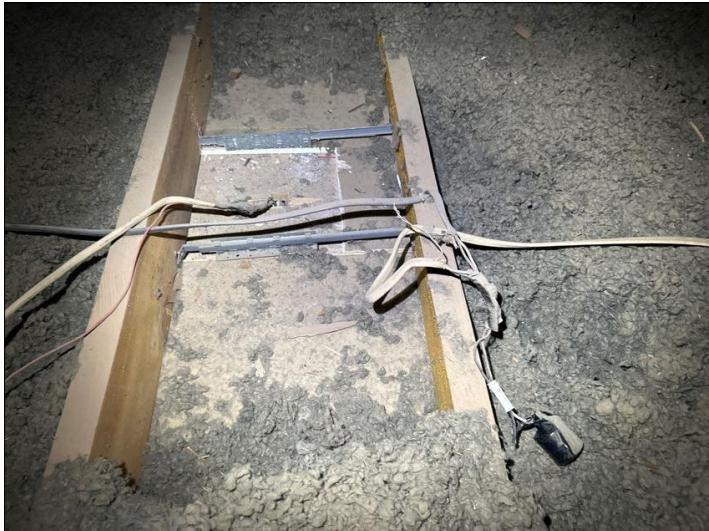
*example of open splice*

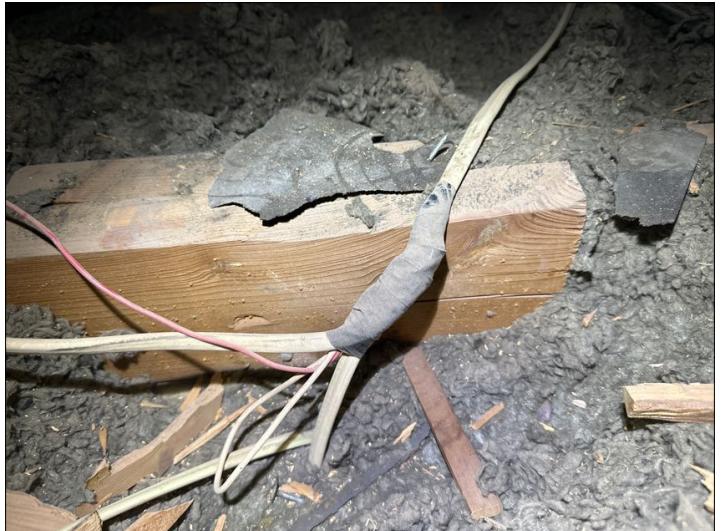
*example of open splice*

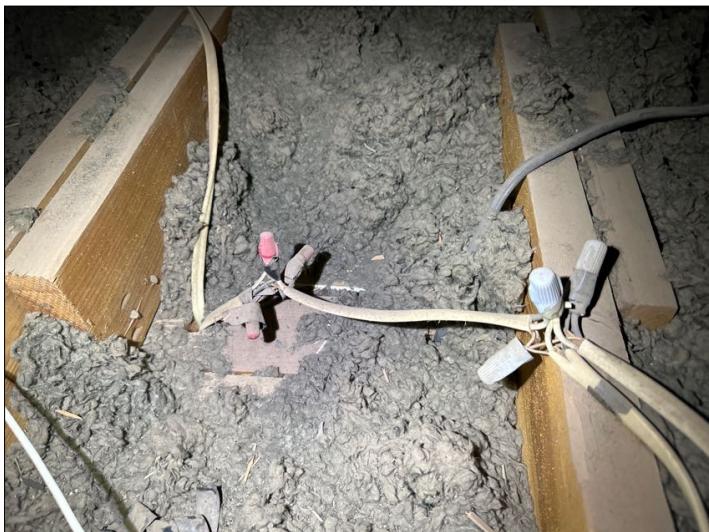
*example of open splice*

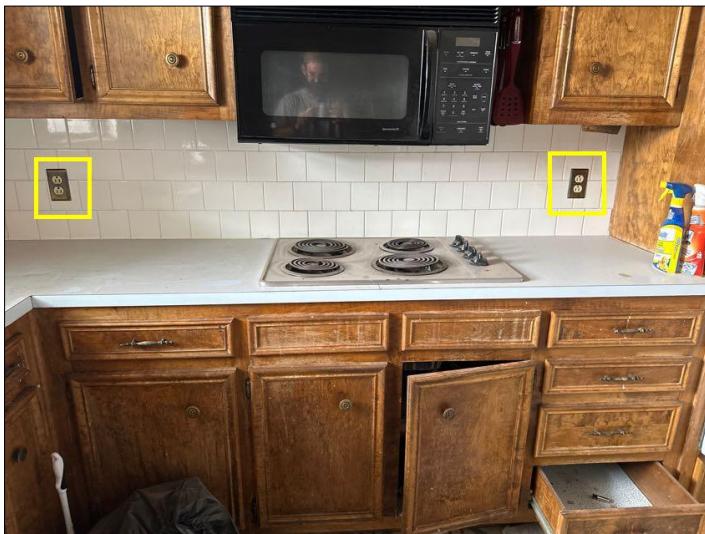
recommend GFCI in kitchen

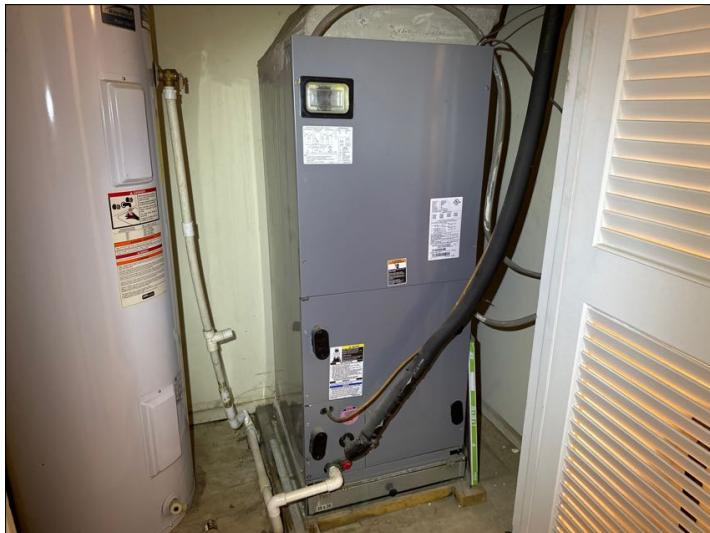
electric furnace/air handler, 2009

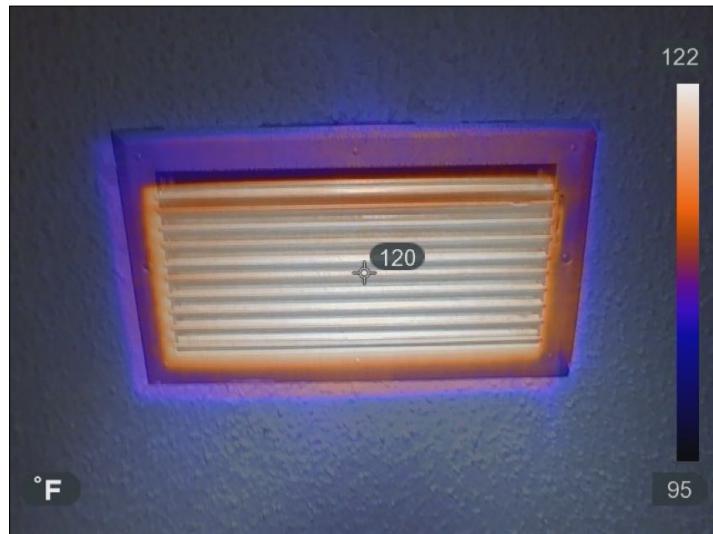
heat in operation; good

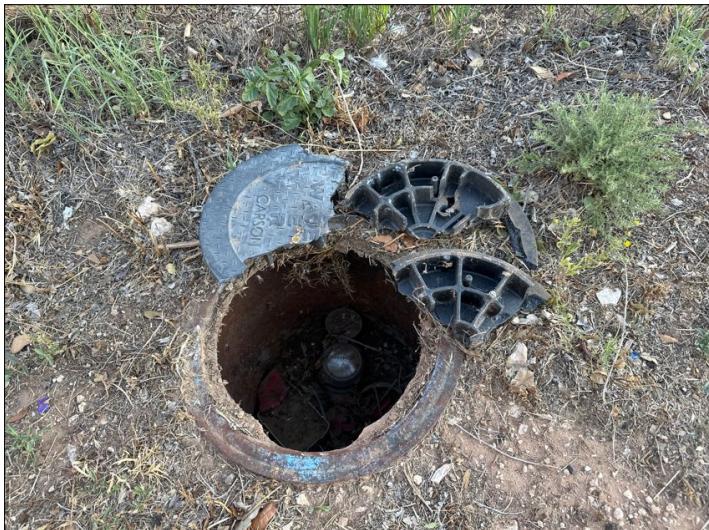
*water meter cover broken*

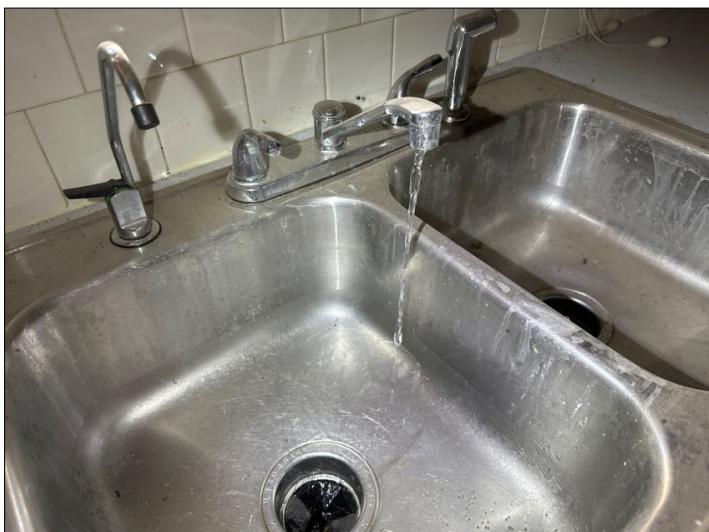
- Recommend any water piping outside of the thermal envelope of the house (attic, garage, exterior, etc) be insulated to prevent freezing &/or improve efficiency.
- Noted localized poor water pressure at a fixture. This may be indicative of a restriction (stop valve, supply hose, faucet valve etc).
- The kitchen sink sprayer was damaged and/or inoperable
- One or more bathroom sinks were observed to have missing/inoperable pop up drain stoppers and/or lift rods.
- Noted water dripping from a faucet handle and/or base. This usually indicates a worn cartridge and/or washer.
- The stop/gate valve(s) in the washing machine box was leaking. Recommend replacement

*low water pressure at kitchen sink*

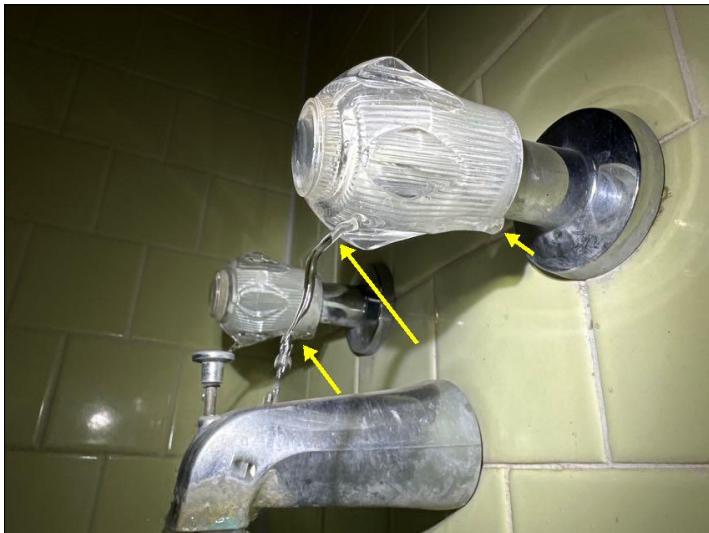
leaking shower valves - guest bathroom

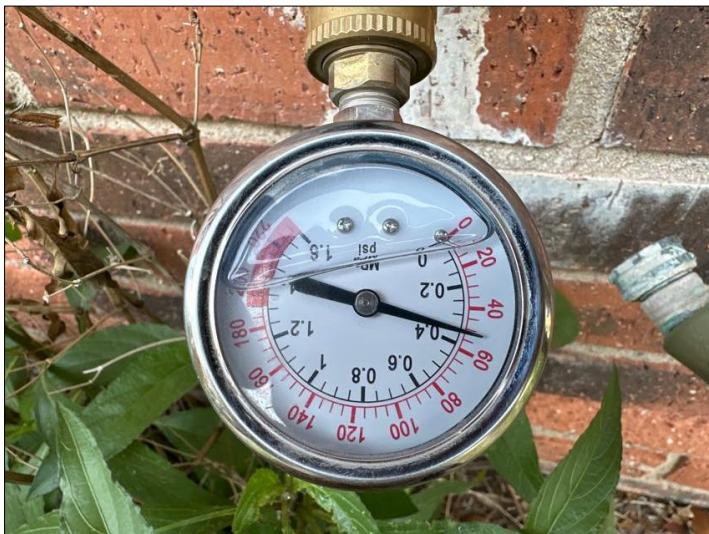
static pressure approx 50 PSI

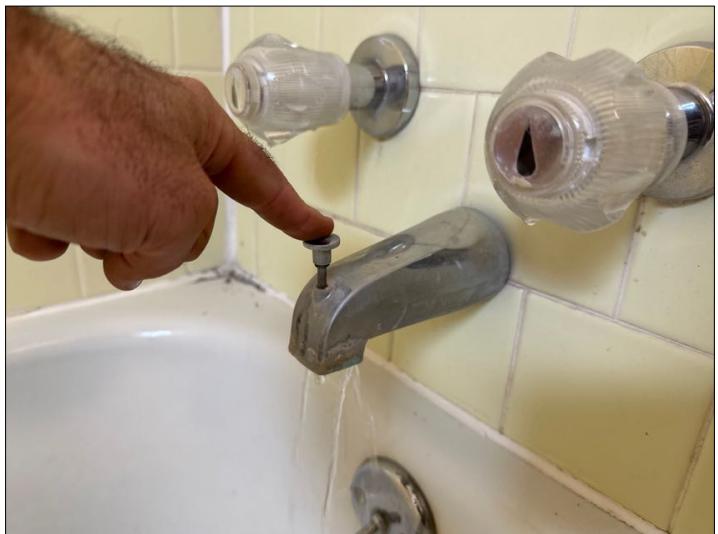
diverter rod sticks

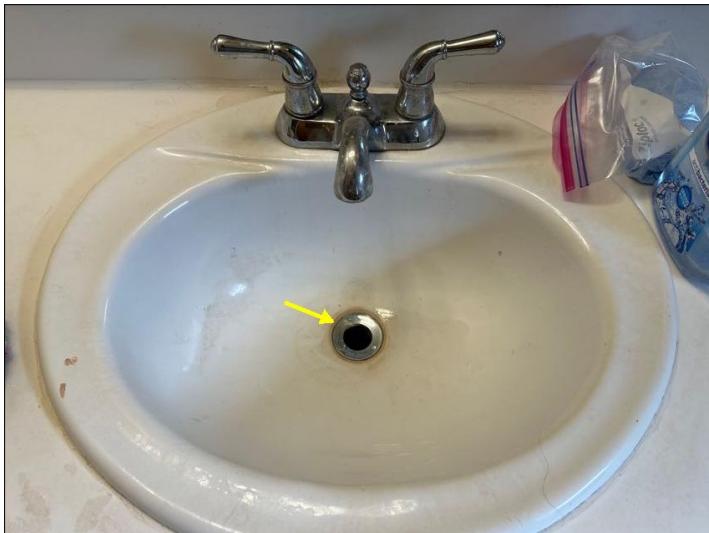
pop up drain missing/inoperable

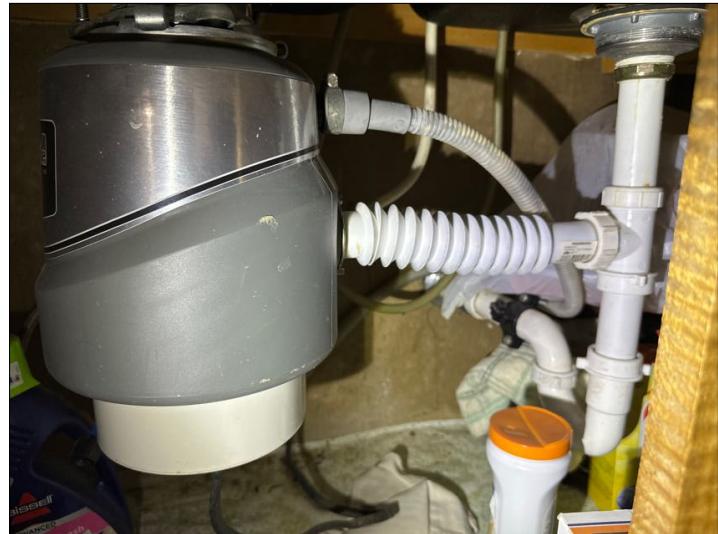
flex/corrugated drain line at kitchen sink

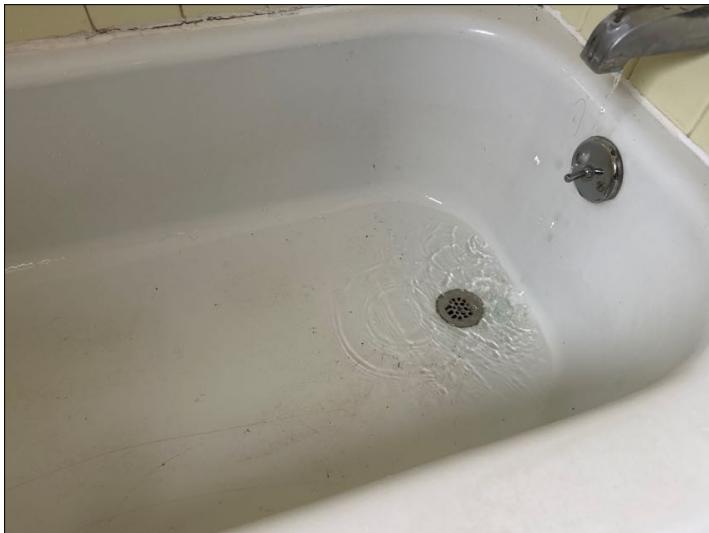
- Noted an obstructed and/or slow draining fixture in one or more areas. Recommend repair. ***the kitchen sink was backing up and draining out of the wall cleanout.
- One or more of the drains appeared to be draining slowly and should be evaluated for an obstruction.
- One or more sinks are piped with flexible/corrugated drainpipe. This product is often used by handymen and homeowners but is not actually approved and could contribute to increased blockages.
- One or more drain leaks were observed and should be repaired. Refer to picture/video

slow drainage noted at guest bath

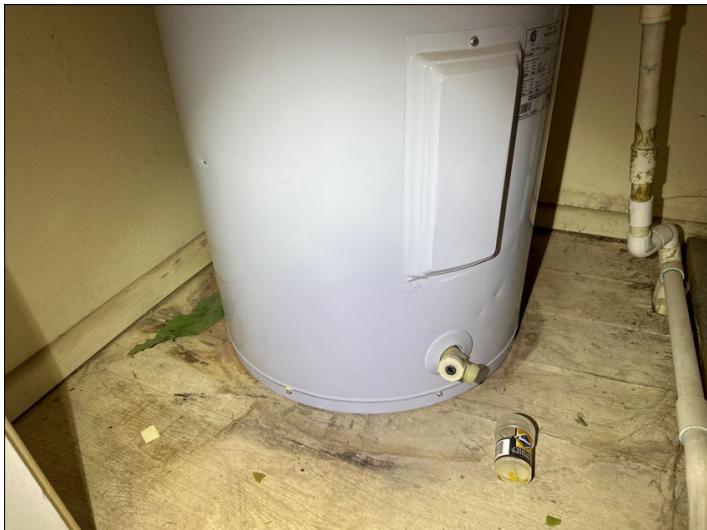
recommend drain pan

- The service disconnect for the water heater is in another room (not within a line of sight) and is not compliant with modern codes.
- PVC pipe is not approved for application as a TPR discharge line because it is not rated for heated water. Recommend connection of approved material, such as CPVC or copper be made.
- Recommend a proper catch pan/drain pan be installed.

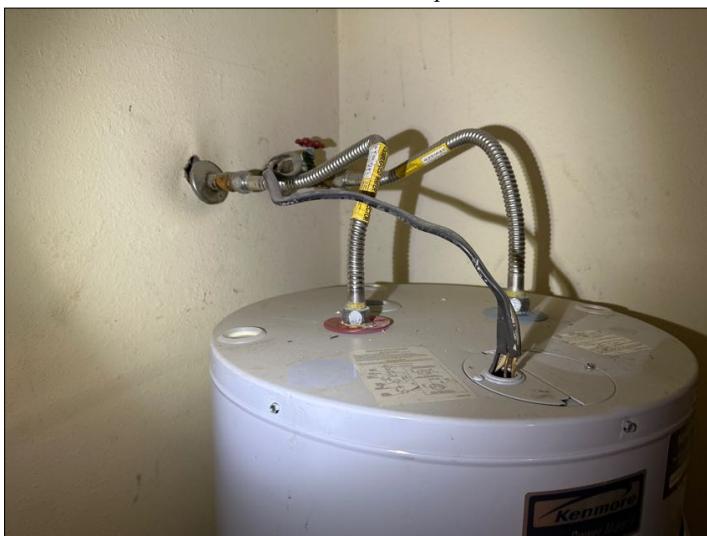
no proper service disconnect

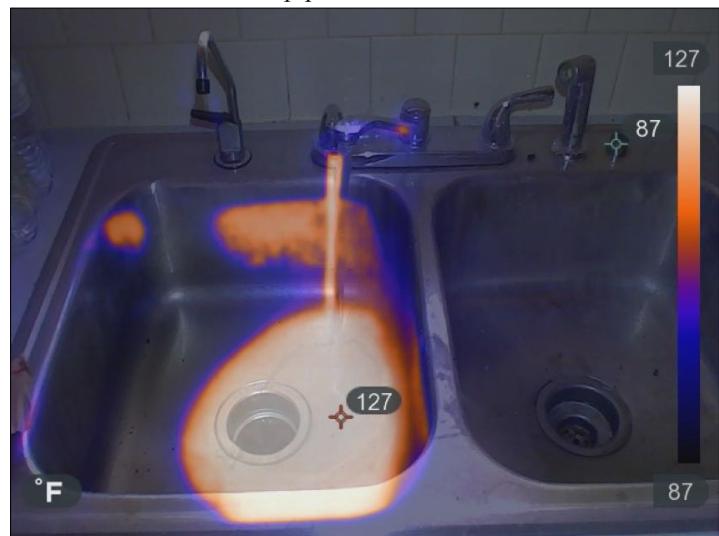
hot water reference photo

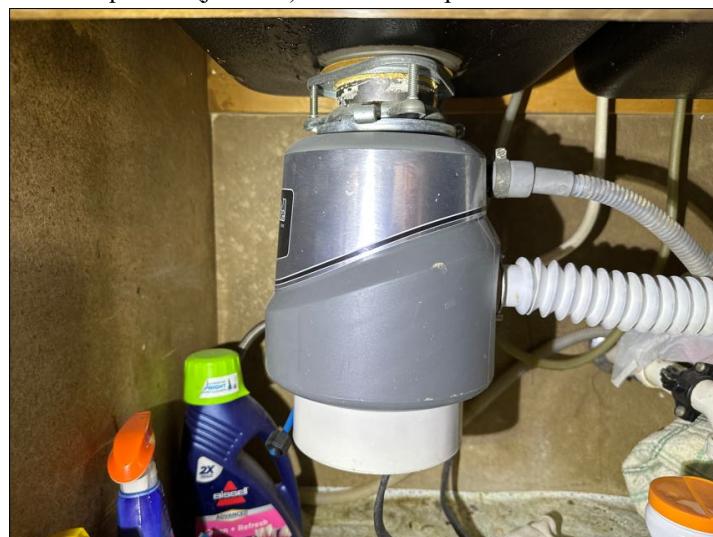
- Disposal was inoperable (jammed) at time of inspection.

*disposal NOT operable at time of inspection*

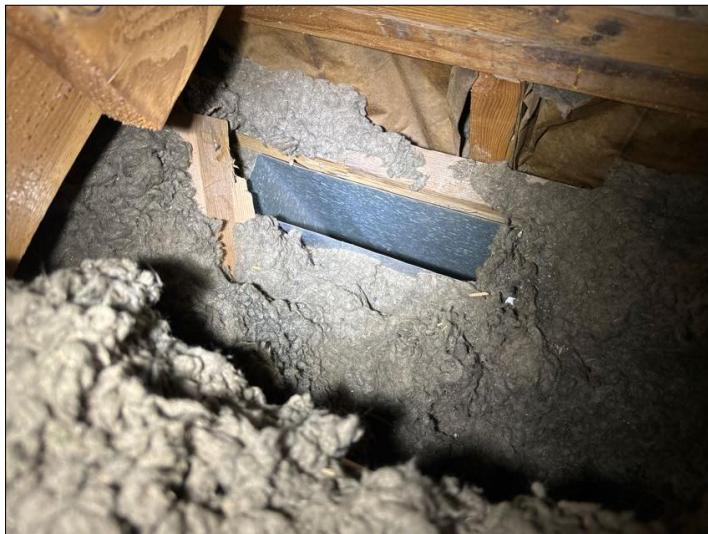
- The exhaust vent was terminated in the attic and should extend to the exterior per current building standards. While this is an 'as-built' condition, we are required to mark it as 'deficient' per the TREC standards of practice.

hood vent terminates in attic

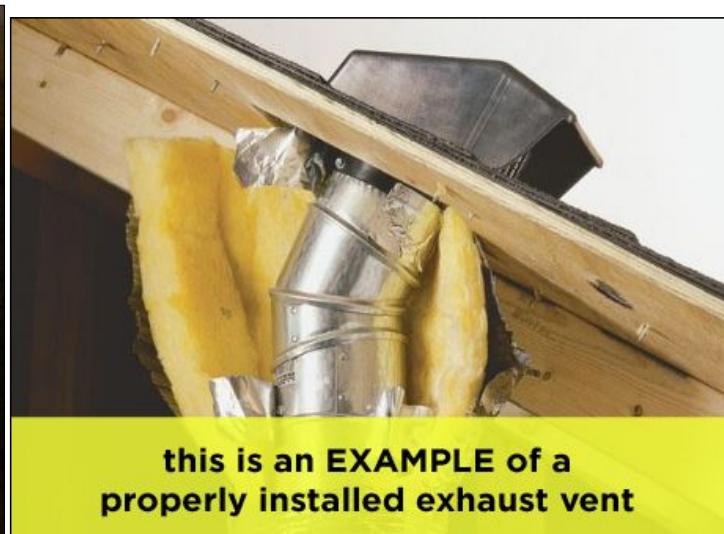
this is an EXAMPLE of a properly installed exhaust vent

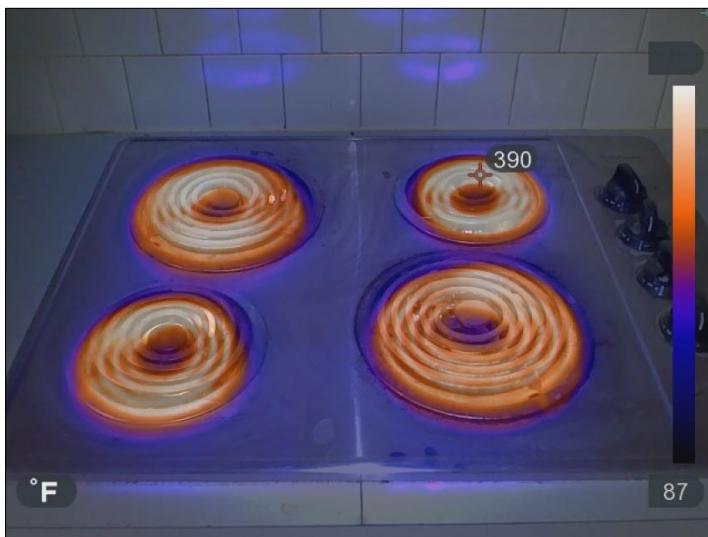
stovetop in operation; good

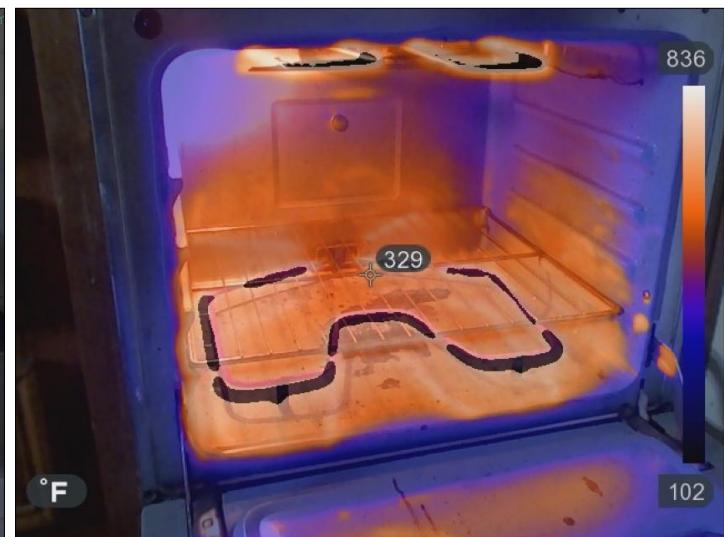
oven in operation; good

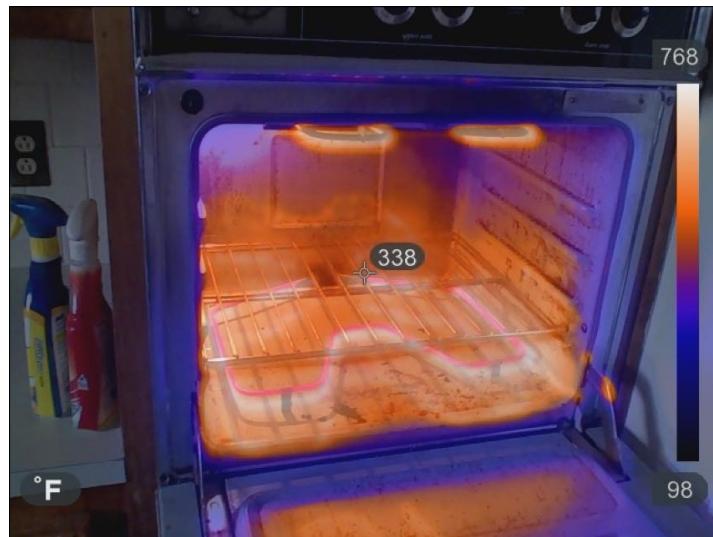
*oven in operation; good*

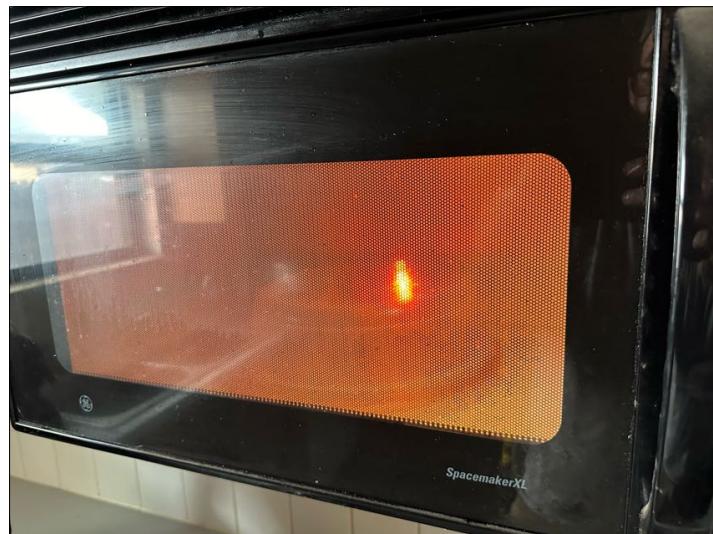
*microwave in operation (with test device); good*

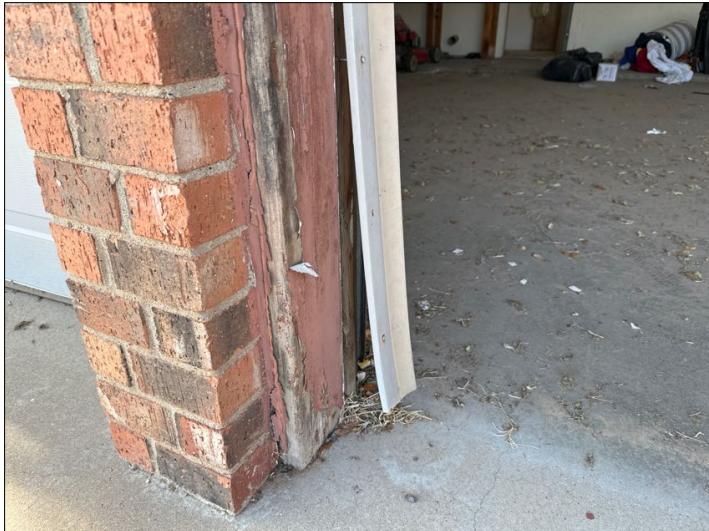
missing/damaged weatherstrip

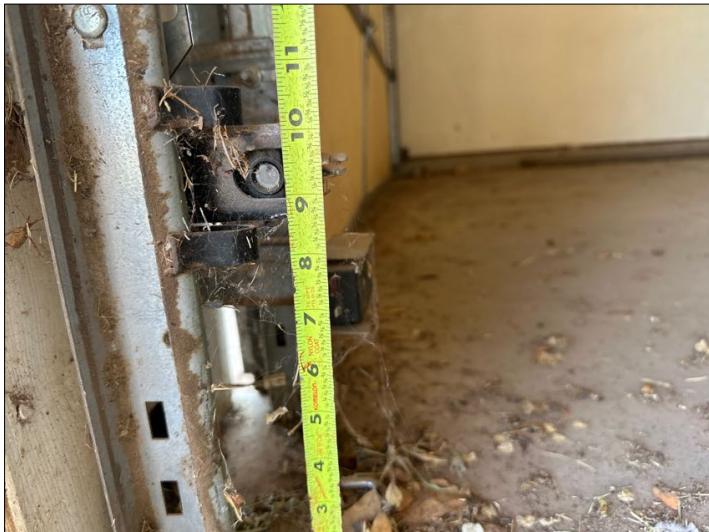
- One or more of the overhead doors/garage doors were damaged and replacement is recommended.
- The garage door sensors were noted as being installed higher than the recommended max of 6" from the ground floor. This must be marked "deficient" per the TREC standards of practice.
- The weatherstripping system at the jamb and/or door bottom is damaged and/or not providing a good seal in one or more areas. See picture(s).
- The doors did NOT open via the openers at the time of inspection. Recommend further evaluation and repair.

reverse eyes installed higher than max 6"

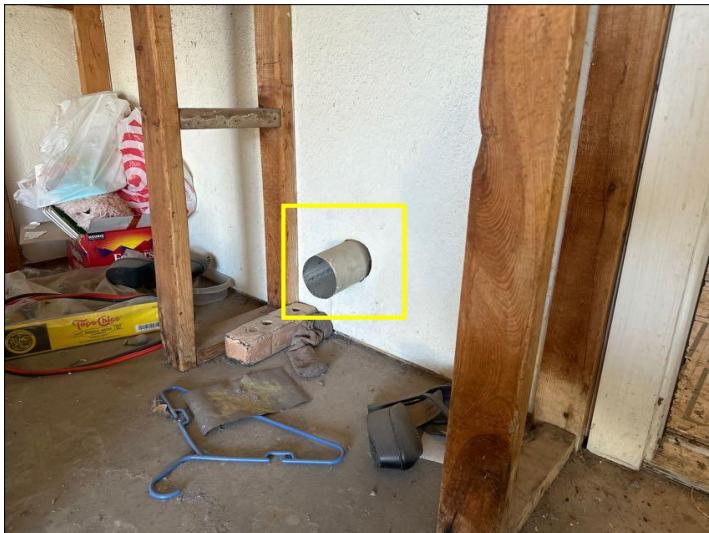
- The dryer exhaust vent is required to terminate to the exterior of the structure per modern building standards.
- The dryer vent is separated/disconnected in one or more areas. Recommend repair.

*dryer vent terminates into garage; extend to exterior*

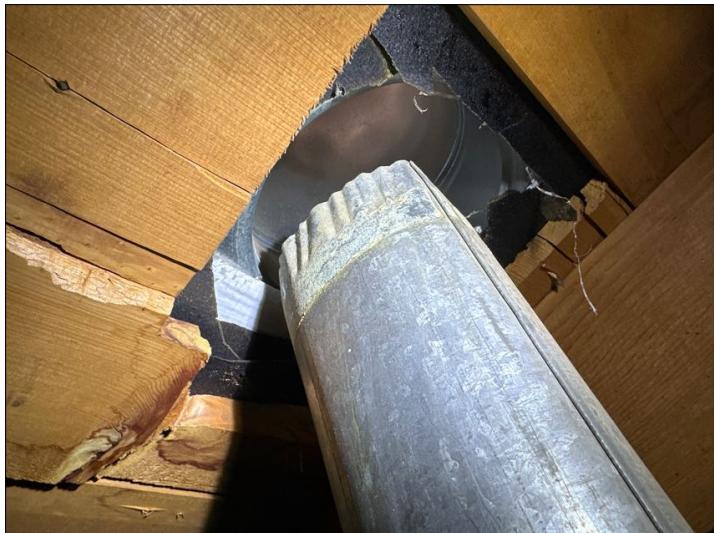
*original dryer vent not properly sealed to roof vent* **I. Other**
